Infrastructure and Ecological Inventory
of the
Neponset River Riverwalk
in Quincy, Massachusetts

Jeffrey Collins
Director, Ecological Extension Service

10 May 2007

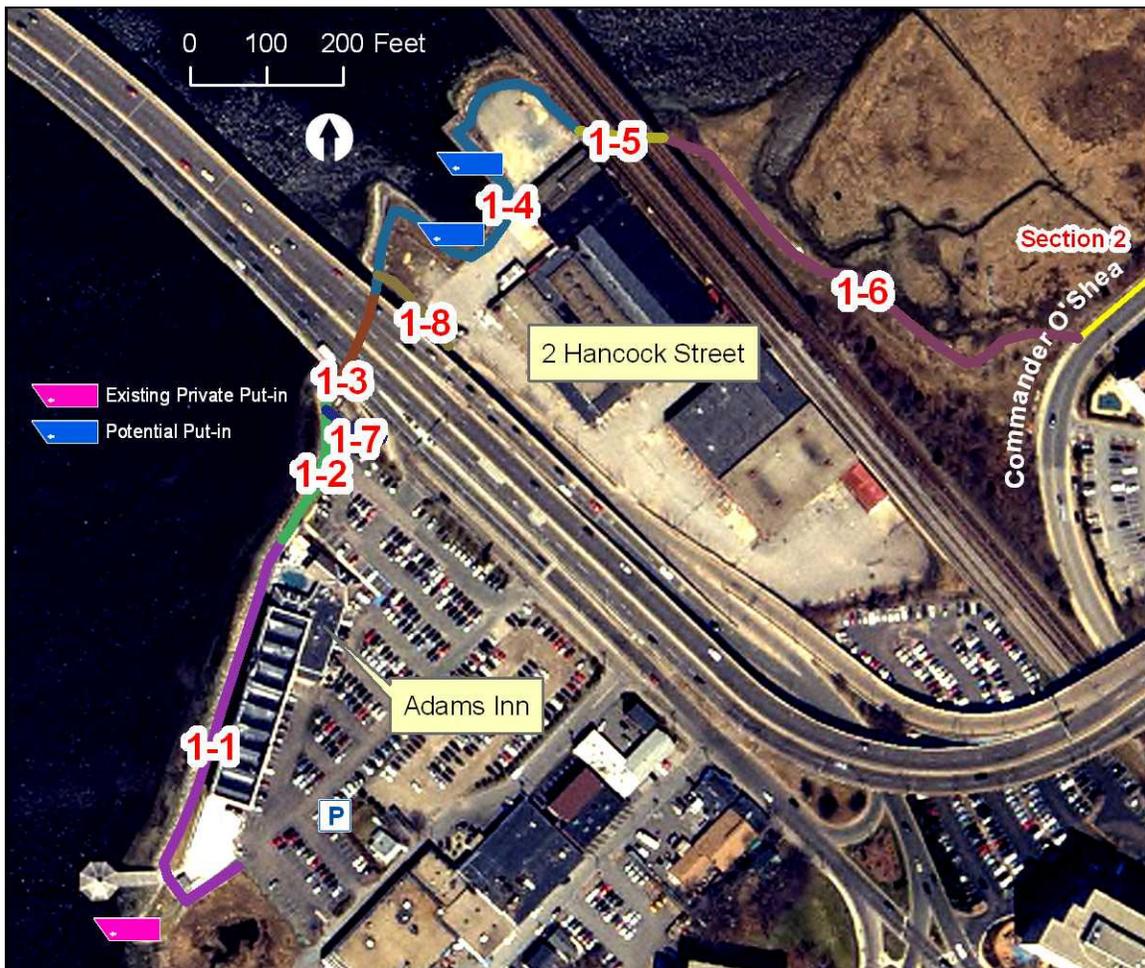
Figure 2 – Squantum Point Trail: Section 1

Section	Length (ft)	Surface	Width (ft)	Condition	Accessibility
1-1	475	gravel/paved	5-6	Very good	fair

A well-built and well-maintained section of trail leading from the Adams Inn parking lot to their riverside gazebo and dock, then roughly 300' to the north to another section of parking lot. The southernmost section, from a parking area to the gazebo and dock, is surfaced with peastone gravel. The 5-6' wide trail running north from the gazebo is surfaced with stone dust. The path is sandwiched between the river and a 3-story section of the Adams Inn, not too far from the rooms which look out onto the river through full-length glass windows. The path reaches a concrete sidewalk at the northern end which leads back to a section of the Adams Inn parking lot. The gravel section rates poorly for accessibility, and the stone dust section only moderately better. The short concrete section is excellent for accessibility.

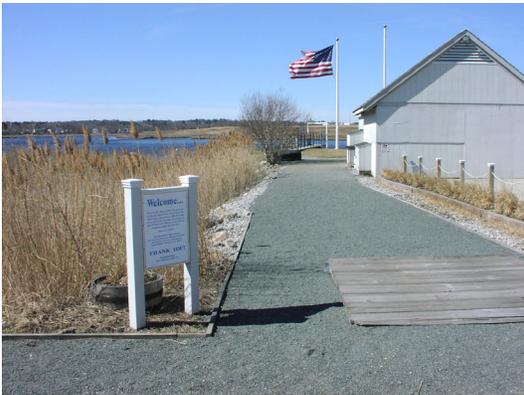
Path from Adams Inn parking lot leading to dock and gazebo. Note public access sign.

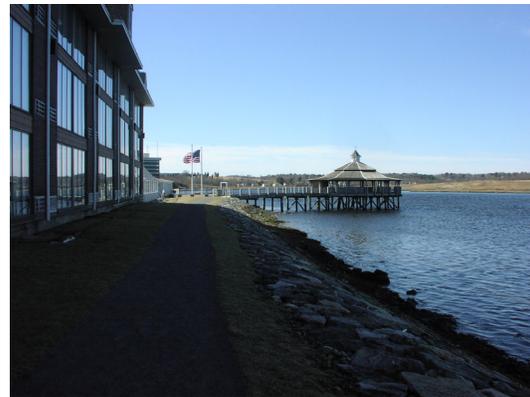
View south alongside Adams Inn towards gazebo.

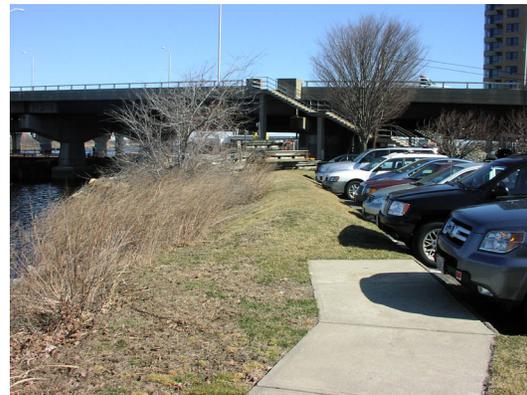
A low grassy berm that running along the Adams Inn parking lot. There is no path in place, although walking along the berm is rather easy. This section would need to be re-graded and surfaced to accommodate a walking path. Unclear whether agreement granting public access to waterfront on Adams Inn property covers this stretch as well.

View north from north end of Section 1-1 to Section 1-2. Neponset Bridge in background.

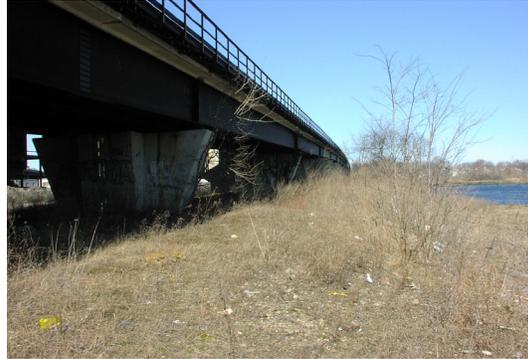
Another short stretch of trail that would pass underneath a bridge, in this case the MBTA Red Line bridge. This section is currently less open and much less trafficked than the area underneath the road bridge, however with some litter removal and vegetation management, could be restored to a pleasant connection.

View to area underneath MBTA bridges.

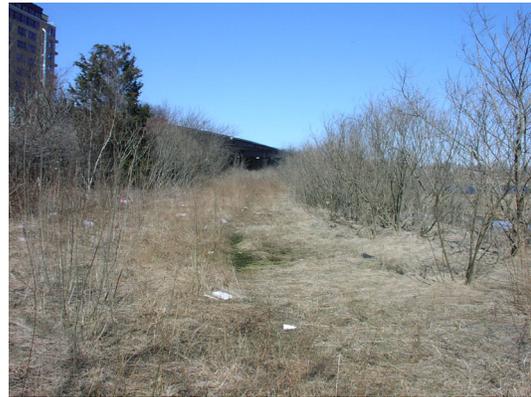
This section features perhaps the nicest views along the entire proposed route of a Squantum Point path. The observer, in one sweeping view, can take in the open river, narrow side channels, and a wide expanse of salt marsh, all with the Boston skyline in the distance. The site is currently little used. Access from Commander O’Shea Boulevard is via a narrow, muddy, informal track through long grasses and weedy plants. This section would need considerable improvement.

Overgrown path in section 1-6.

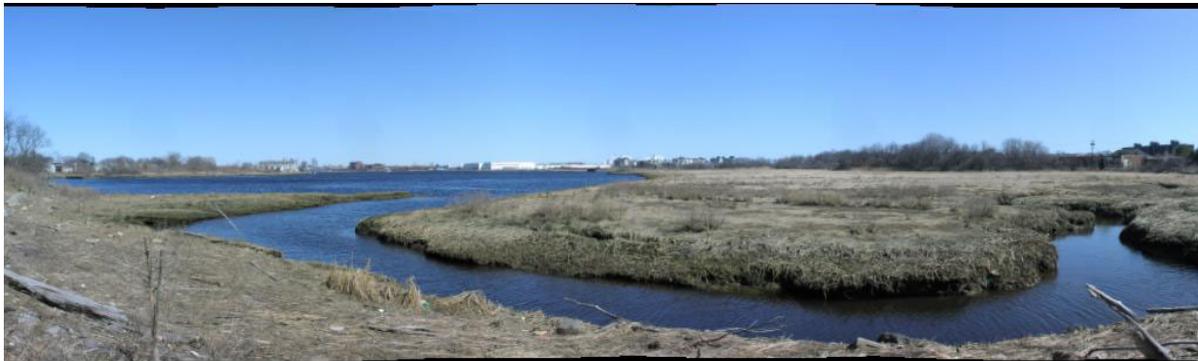
Panoramic view of Neponset River, side channels and salt marsh, north from section 1-6.

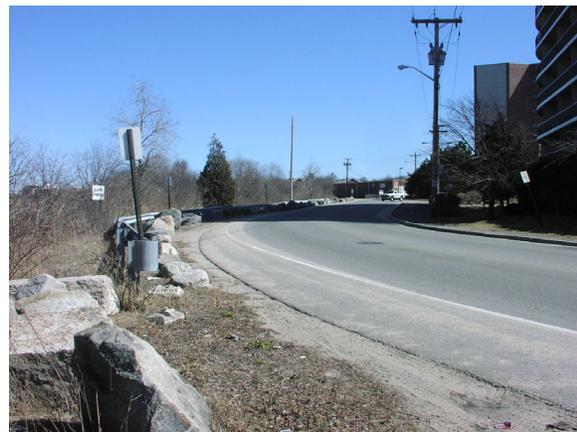
2-1 – There is no formal pathway along this stretch of Commander O’Shea Blvd. A narrow gravel informal path running directly adjacent to the roadbed on the west side is lined with large boulders which make passing difficult. The east side is similar, with a 4 foot wide informal path atop the curb running adjacent to the road, but without a formal sidewalk. Decent visibility in both directions on Commander O’Shea Blvd. make this a potential crosswalk location.

View north along Commander O’Shea Blvd. from Section 1. Note boulders on left of road.

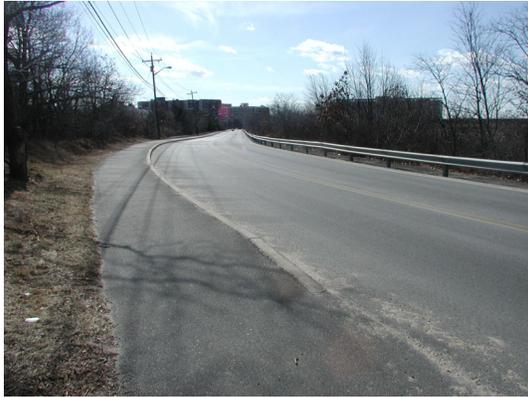
A five foot wide, nicely paved sidewalk along the east side of Commander O’Shea Blvd. An informal gravel path runs along the west side of Commander O’Shea Blvd., separated from the road by a guardrail. This informal path creates a connection from Section 2-1 to section 3-1 without crossing Commander O’Shea Blvd., and it provides slightly better views to the Neponset River to the west, but is not as well surfaced.

View south along Commander O’Shea from junction with Section 5.

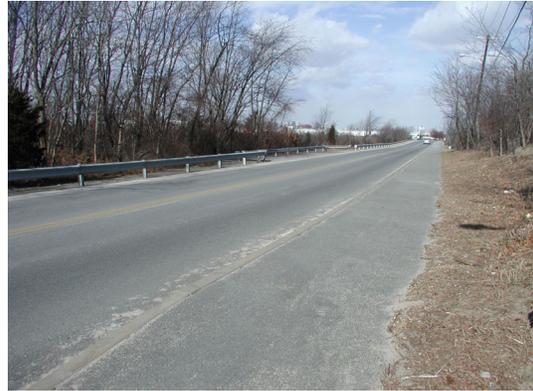
View north from intersection with Section 5. Note parking pull-out on left of road.

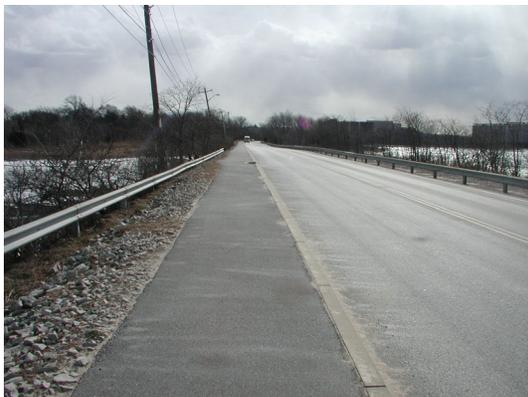
View south along Commander O’Shea from junction with Section 8.

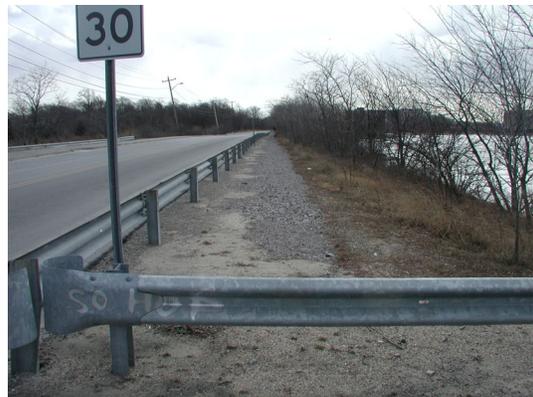
View south along Commander O’Shea from parking pull-out at junction with Section 3.

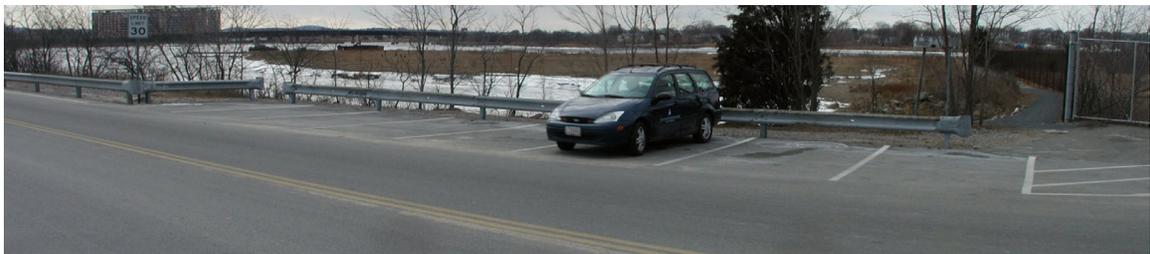
Parking at north end of Section 2-2 off of Commander O’Shea Blvd. Section 3-1 begins at right.

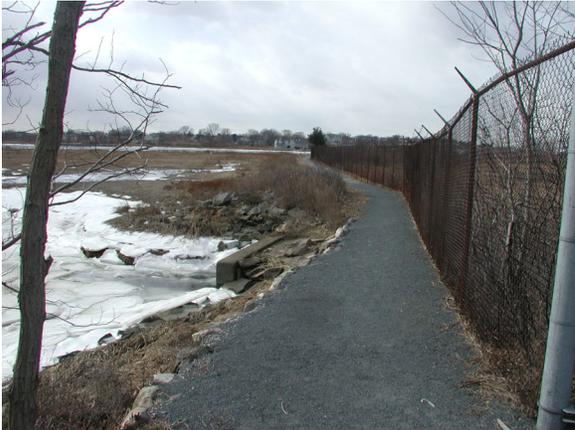
A five foot wide stone dust path between the Boston Scientific perimeter fence and the rip rap Neponset River bank. The surface is rough in some areas where erosion has created small channels through the stone dust. This stretch of path provides excellent views onto the river; however, the wide open nature of this section also leaves visitors exposed to winds. The land directly inside the perimeter fence is characterized by scrubby vegetation at the southern end, and parking lots at the north.

Section 3-1 looking west from parking area beside Commander O'Shea.

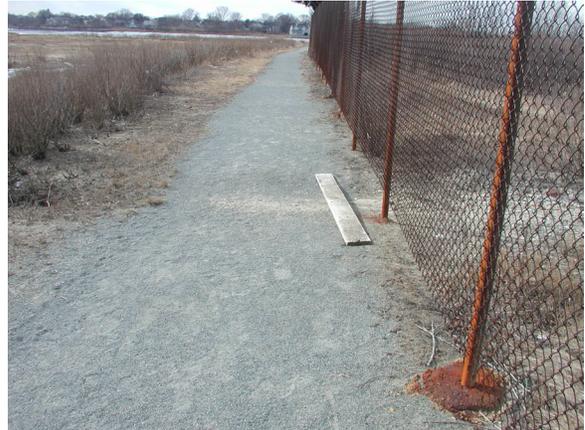
A second area of erosion.

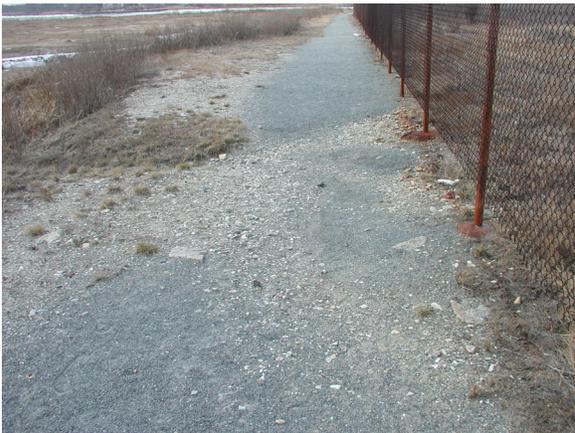
An area of trail erosion from run-off.

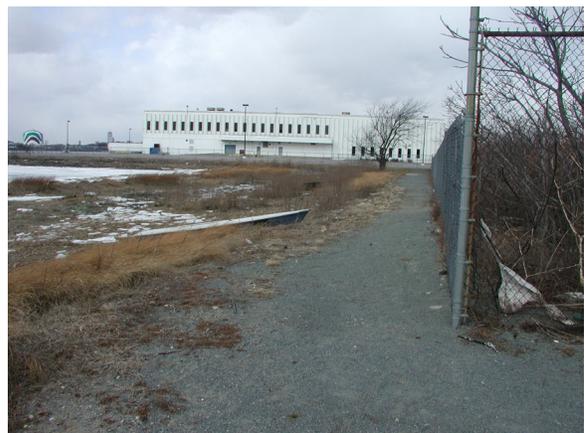
View north along the Boston Scientific perimeter fence.

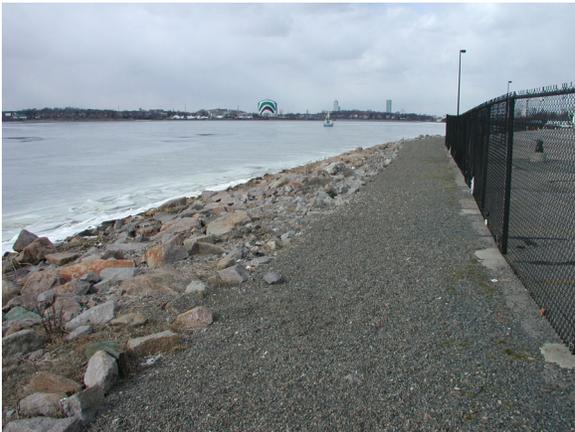
Similar to 3-1, but with gravel surface rather than stone-dust. Gravel is looser underfoot and a little more difficult to walk on. The trail runs between the Boston Scientific perimeter chain link fence and the riprap bank of the Neponset River. The land inside the chain link fence is primarily parking and loading docks. This section provides additional dramatic views onto the river, but is also exposed to the wind. A significant amount of litter, in the form of river-borne and tidal flotsam, lies strewn amid the riprap.

View north along trail from Section 3-1.

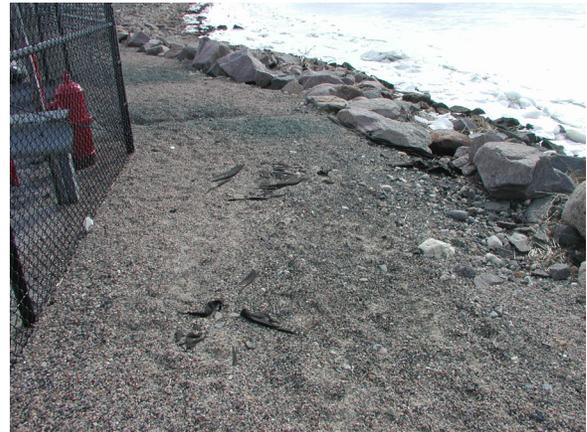
Area of slight erosion along path.

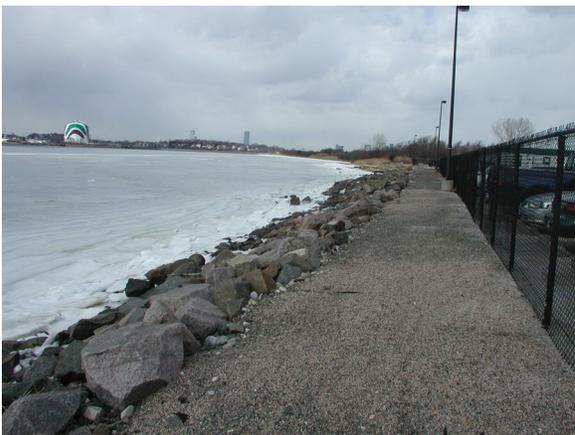
View north to end of Section 3-2

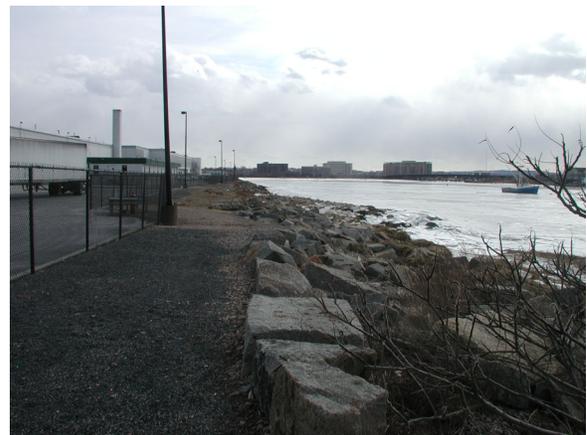
View south from northern end of Section 3-2.

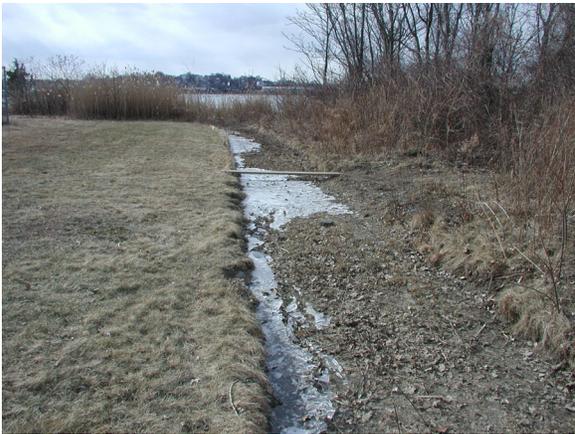
Drainage is a major issue along this section, with large, deep puddles across the path in several locations, particularly at the north end where it connects to section 3-4. There is some informal maintenance by users, as evidenced by pruned branches along the path. May be entirely passable in dry season. A large (10') berm is found roughly half-way along this section of trail. It appears to be composed largely of discarded pavement and dirt. An informal trail winds over this berm, a short section of narrow, steep, dirt footpath.

Drainage channel at south of Section 3-3.

- 3) Connection between Sections 3-2 and 3-3 – An open drainage channel separates the two sections. While dry most of the year, wet conditions may make this 15-foot wide channel un-crossable. A small bridge or boardwalk should be installed.

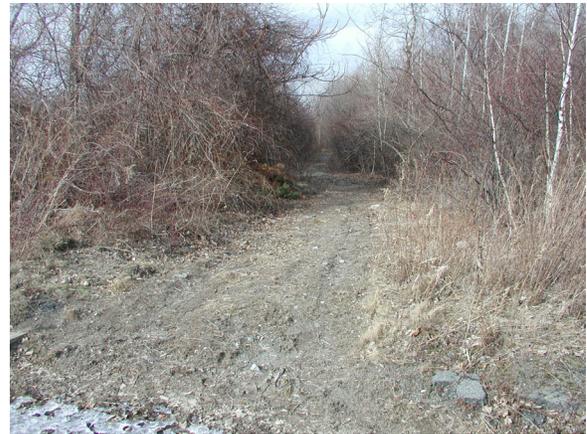
A little-maintained, former path within the Squantum Point State Park property. This stretch follows the route of an access road for the old airfield, but is now largely grown in with 15-foot high shrubs on either side. An 8-foot wide open drainage channel at the southern end of this section could make access difficult during rainy periods. A wooden plank currently assists with crossing. The trail surface is primarily dirt and accumulated leaf litter, although some pavement from the former roadbed appears. Shrubby vegetation has grown in on both sides, narrowing path to 4' in some places. In other places, path is 15' wide.

View north into southern end of Section 3-3.

- 2) Section 3-3 – this section of trail in Squantum Point Park is overgrown and littered, appearing completely un-maintained. Large water puddles make the trail impassable in wet conditions, and a berm of dumped asphalt and dirt across the trail hinders access. Restoration and maintenance of the trail should be discussed with Park management.

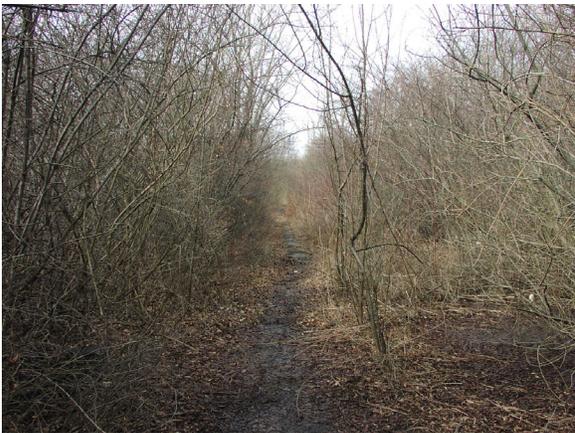
Narrow stretch choked with vegetation.

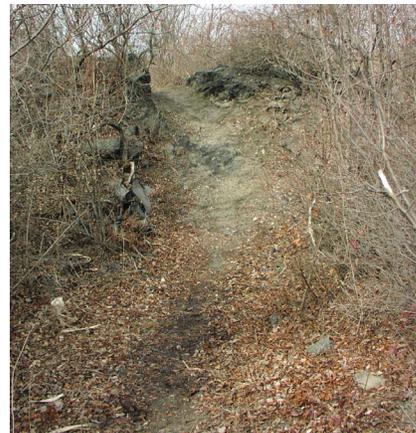
Narrow trail over dirt berm.

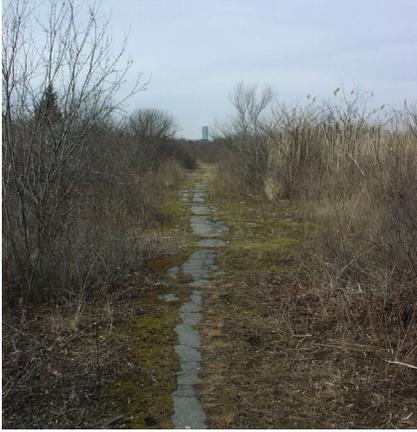
More open stretch of Section 3-3.

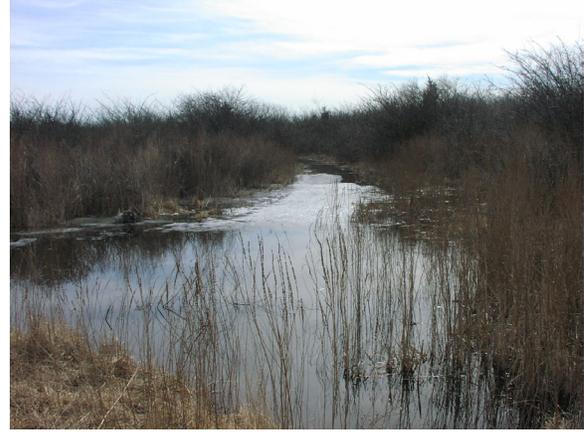
Large puddle at northern end of Section 3-3.

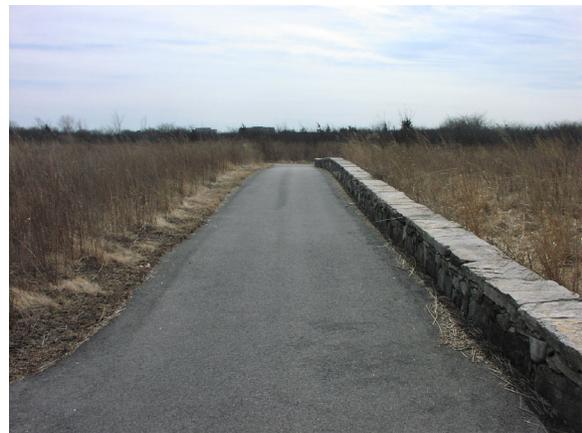
A stretch of paved path which is part of the larger path loop from the Squantum Point Park parking lot, along the former runway path, to the concrete viewpoint to the northwest. Trail is 10' wide, nicely surfaced, with low stonewalls for sitting. Interpretive signage along the larger path (Section 3-9) describes the aviation history of the site. The sitting area at Squantum Point is perhaps the most pleasant location on the entire trail network.

Paved path in Section 3-4 with low wall.

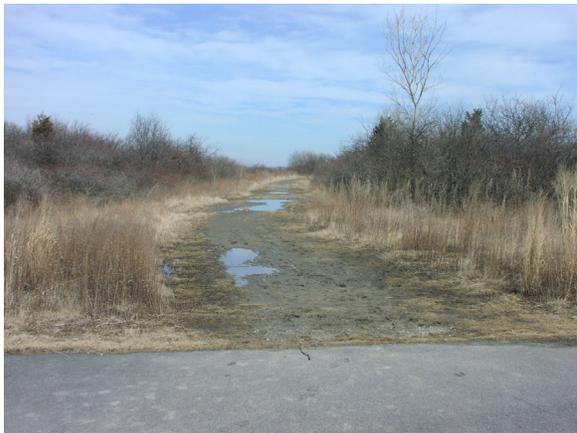
This section runs from the nicely paved trail of Sections 3-4 and 3-9 along the waterfront and back to the parking areas. The trails holds some puddles in wet conditions, most of which are easy to walk around. Wet conditions also make the sandy surface quite soft, making access somewhat difficult for those unsteady on their feet. The trail may be similarly difficult in very dry conditions. The trail passes through shrubby vegetation at its southwest end, then runs along the water's edge affording fantastic views to the north.

View north along trail from Section 3-4.

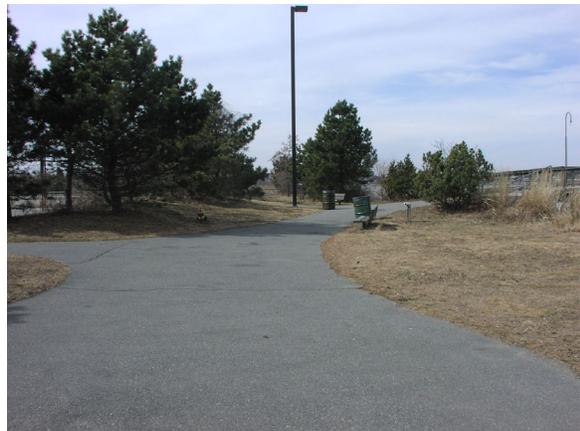
This wide paved trail winds along the water's edge to the north of the large Squantum Point Park parking lots. The trail leads directly to the large pier which stretches 300 feet out into the harbor and affords outstanding views across the water from northwest to northeast. There are a few benches along this stretch as well as trash barrels.

View east along Section 3-6.

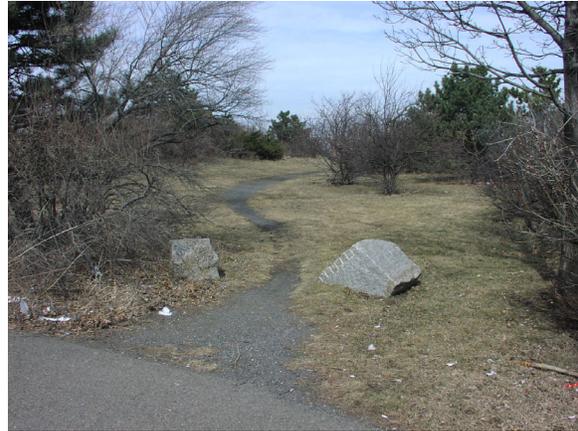
This short section of stone dust trail leads from the east end of Section 3-6 to the connection with Section 4. The appearance of the trail is somewhere between an informal desire line, created by repeated use, and a semi-maintained alternative route to the waterfront. Some surface improvement would be advantageous.

Section 3-7 near junction with Section 4.

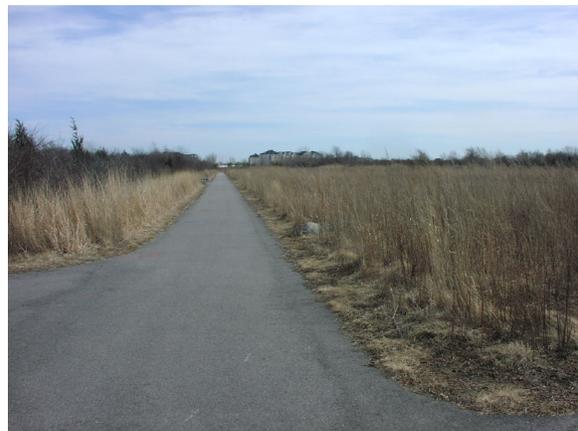
This wide loop of paved trail follows the layout of one of the major runways that formerly occupied the site. The main section of trail leads from the southwest corner of the large Squantum Point Park parking area directly to the Squantum Point sitting area and lookout. A second loop of equal width and excellent conditions runs parallel 150 feet to the south. Four cross trails connect these two main trails (one of which is designated Section 3-4). Low stone walls, which are excellent for sitting, and interpretive signage are found along the length of the trail.

View southeast along Section 3-9.

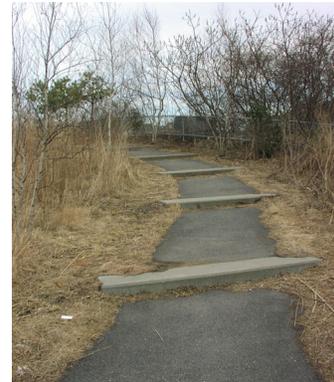
This small section is called out for its inaccessibility due to stairs, however Section 3-9 provides an accessible and most direct route between parking and the view point at Squantum Point. This optional loop leads to a slightly raised point which affords views northeast along the grassland.

Stairs in Section 3-10.

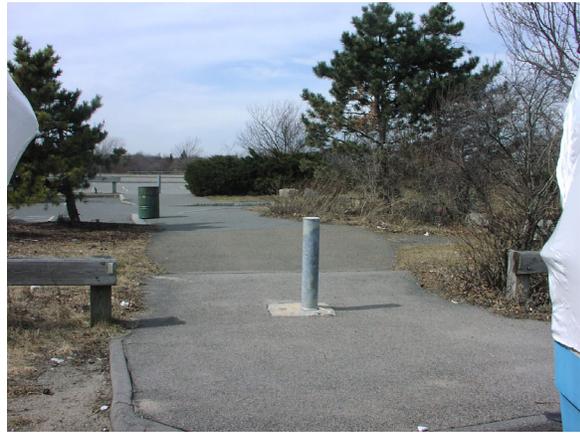
This stretch follows existing sidewalks to skirt one of the marina parking lots. The sidewalks are not in excellent condition, narrowing at some points to under 4'. The sidewalk connects to Section 3 with a pleasant entrance to Squantum Point Park, and connects to Section 4-2 through a short, pleasantly landscaped, paved walk.

Connection from Section 4-1 to Section 3.

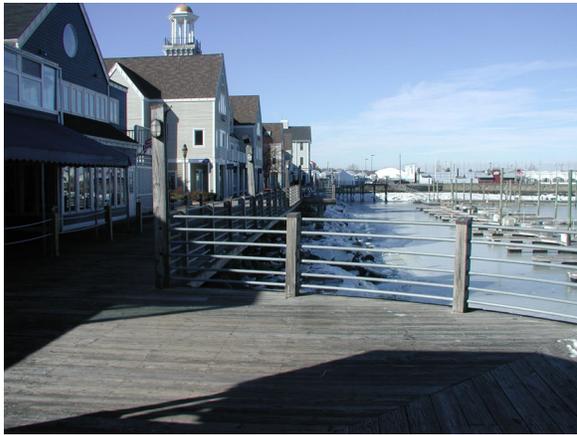
A stretch of boardwalk running in front of commercial establishments along the Marina Bay basin. The boardwalk provides very nice views into the marina, with benches, trash cans, and opportunities to purchase food and refreshment.

View west along boardwalk.

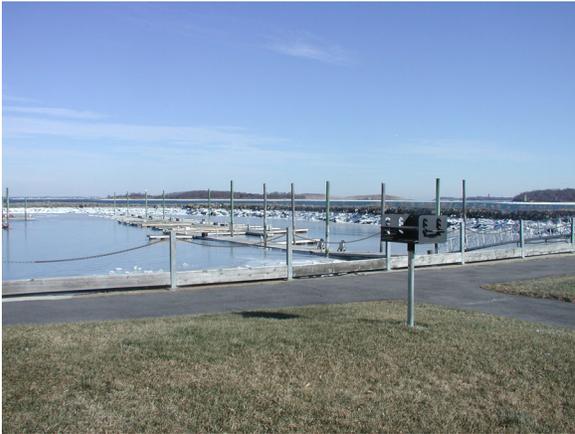
A section of paved paths servicing the marina to the east of the boardwalk. Visitors to the boardwalk can continue along this section, past additional food vendors, to the docks of the second marina basin. A wide paved path runs along the top of the docks, providing excellent views north and northeast to the Boston Harbor and Harbor Islands. There are two or three hibachi-type grills for picnics, although these may be reserved for marina customers. A narrower, shaded path runs alongside the large parking area south of this dockside path. This section is directly adjacent to a large parking area (100+ cars).

Dockside path and view northeast.

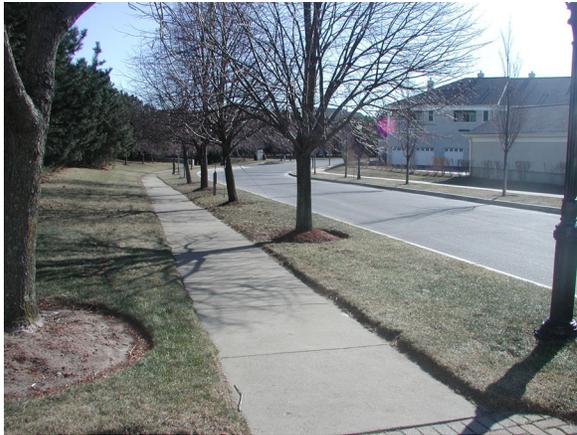
A long section of new concrete sidewalk in excellent condition. The sidewalk is roughly six feet wide, with a curb, and set back from Marina Drive behind a line of very nice street trees. There are curb cuts at each driveway and access road, but no crosswalks. This is a very pleasant walk with attractive houses on the southwest side of the street.

View east along Marina Drive.

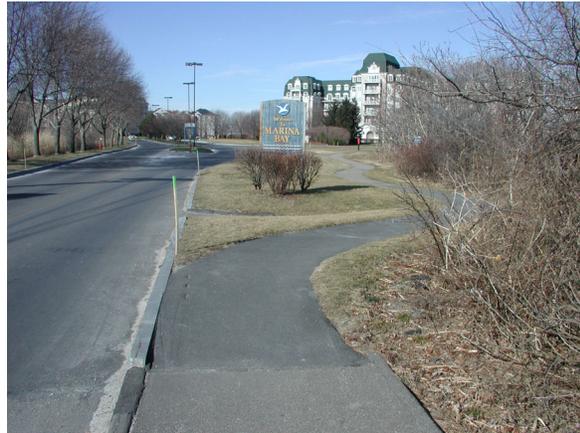
This stretch of paved trail along the east side of Marina Drive connects directly to Section 4-6, but is routed away from roadside, winding through a maintained lawn area. Potential exists for attractive views into salt marsh and tidal flats to the East. The view are partially obscured by wetland edge vegetation.

Southeast end of Section 4-7.

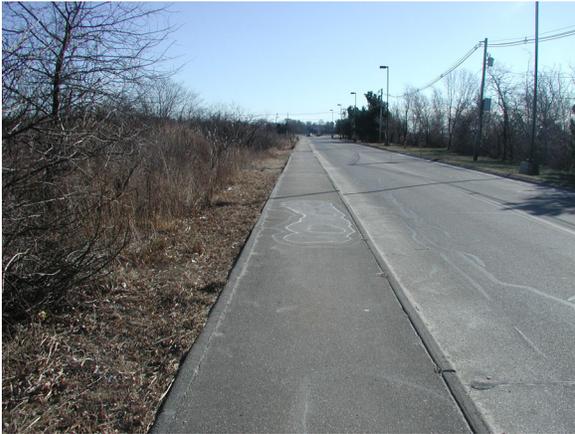
An older section of sidewalk, in good condition, running along the north side of Victory Road. Potential views to north are currently obscured by vegetation. A parcel of conservation land to the north of Victory Road, near the intersection with East Squantum Street, would be a fine location for a park, with improved access and views into the salt marsh and tidal flats to the north. Several curb cuts exist for access to this lot.

View east along Victory Road

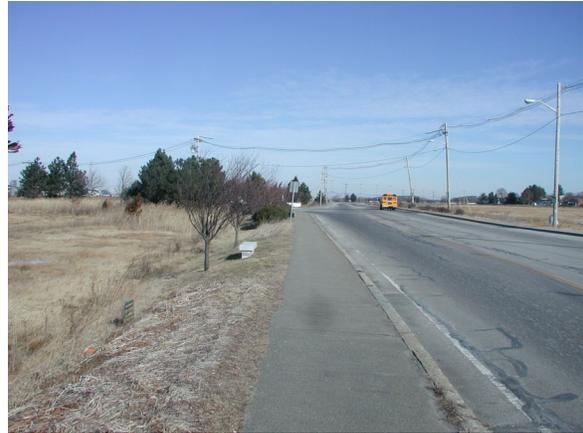
A stretch of paved sidewalk along the west side of East Squantum Street in very good condition. The roadbed and sidewalk are bermed up, affording excellent views into salt marsh both to the west and the east. Volunteer-maintained planting beds line the west side of the road, and benches and a trash can give a sense of a well-ordered path.

View north along East Squantum Street.

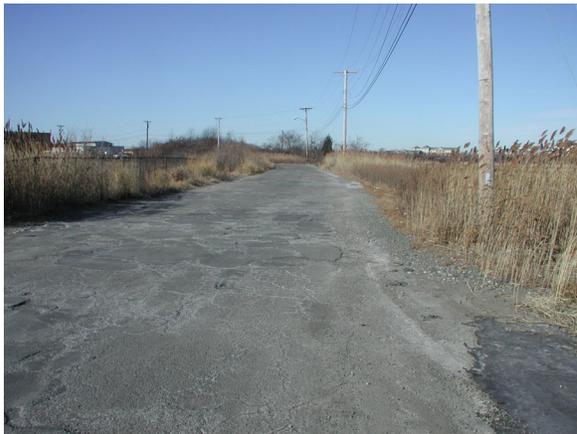
An unsightly stretch of potholed and patched road leading to the city school bus depot and an auto body shop. Potential views north into salt marsh are currently obscured by vegetation. The road is used regularly by school buses and cars. There are no sidewalks.

View from East Squantum Street

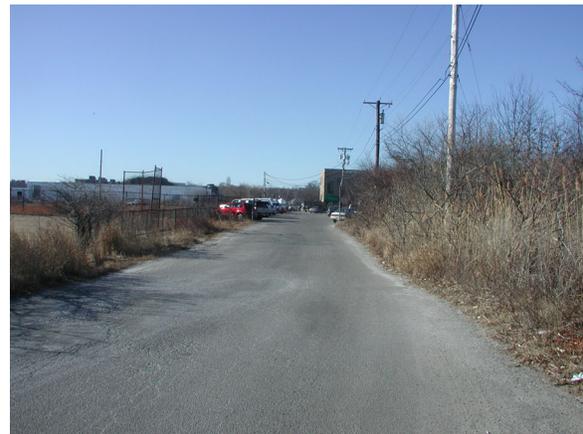
View west along access road to auto body shop.

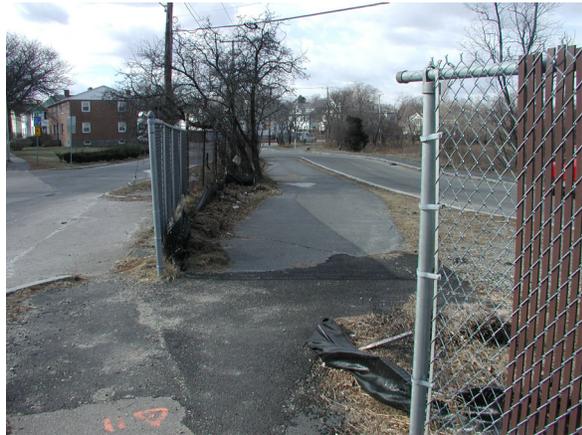
A short section of paved sidewalk leading from Quincy Shore Drive to Section 5-6.

Paved path leading to Section 5-7.

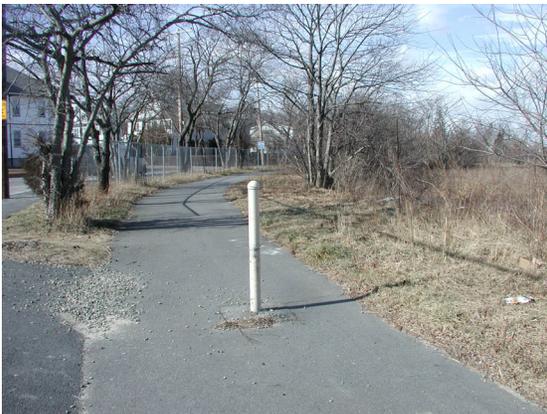
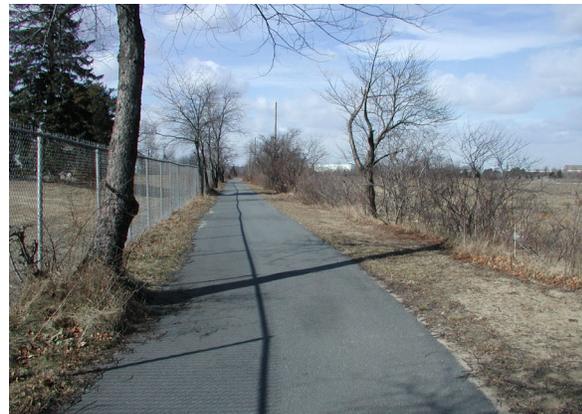
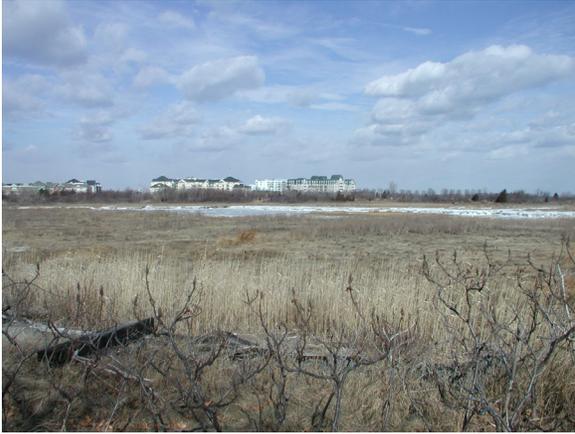
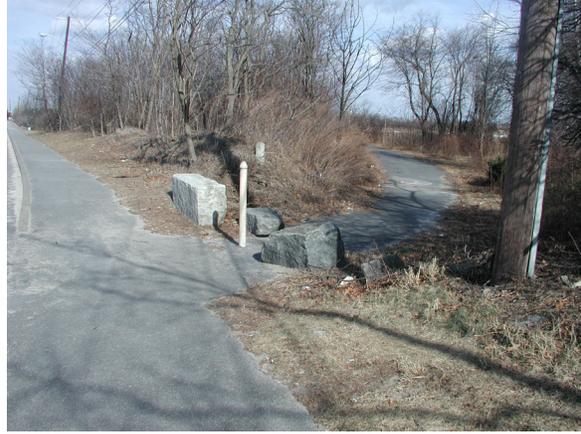
A very nice paved path running alongside and providing excellent views into the salt marsh. The path appears to be little used presently, with a fair amount of litter and some graffiti found along its length. The path provides an excellent connection back to Commander O’Shea Boulevard and section 2-2.

Southeast entrance to Section 5-7.

Northwest along Section 5-7.

View into salt marsh from Section 5-7.

Entrance from Commander O'Shea Blvd.

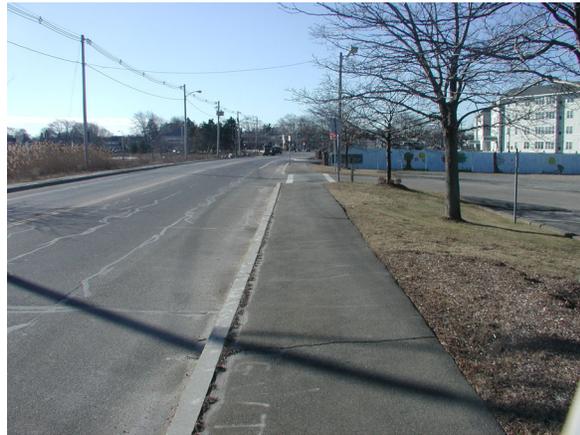
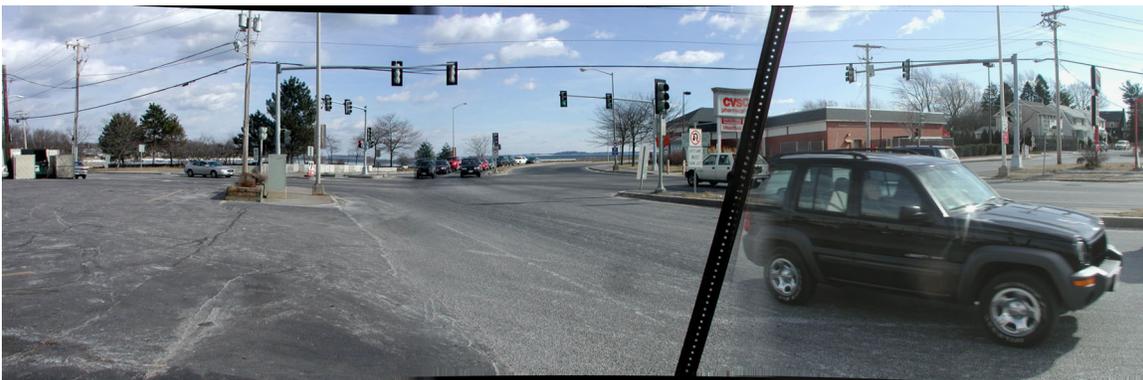
This is a continuation of the very nice sidewalk of section 5-2, running along the west side of East Squantum Street. The sidewalk leads south to the busy intersection with Quincy Shore Drive. The intersection has crosswalks in all directions, and pedestrian-activated crossing signals. The Dunkin Donuts parking lot at northwest corner of this intersection does not include crosswalks and requires care to cross safely.

View south along East Squantum Street.

Panorama of Quincy Shore Drive/East Squantum Street intersection. Dunkin Donuts lot at left.

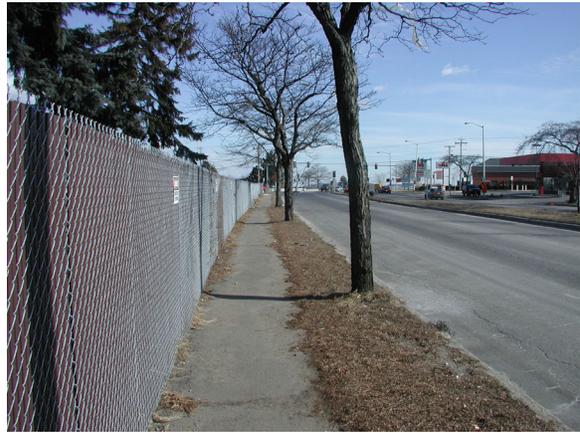
A section of sidewalk running along the north side of Quincy Shore Drive. Sidewalk is older and narrower than that found in other sections, and the surface is more uneven with tree roots and small potholes present.

View east along Quincy Shore Drive.

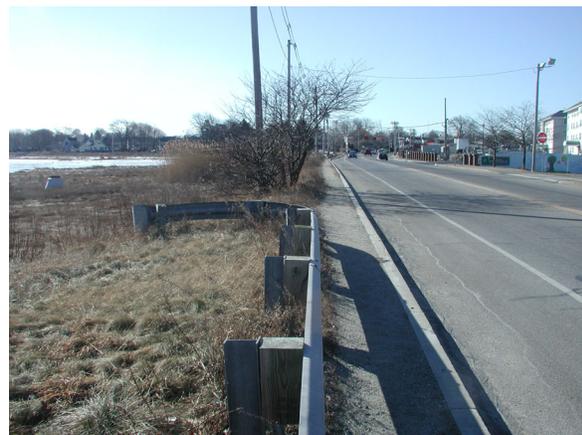
An informal gravel track running along the east side of East Squantum Street. The path links the parking lot of Section 7 with the continued informal paths leading to Wollaston Beach to the southeast along Quincy Shore Drive. A crosswalk at the north end connects across East Squantum Street to Section 5.

View south along East Squantum Street.

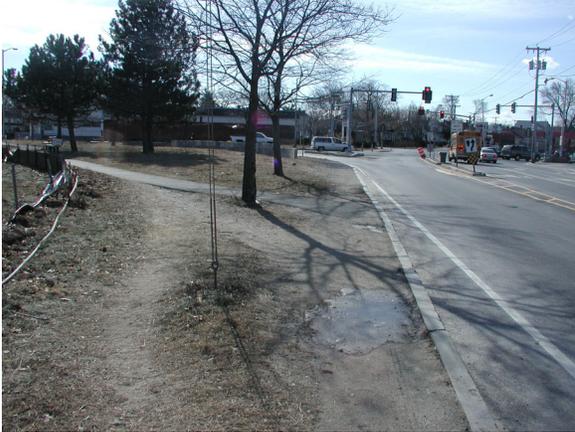
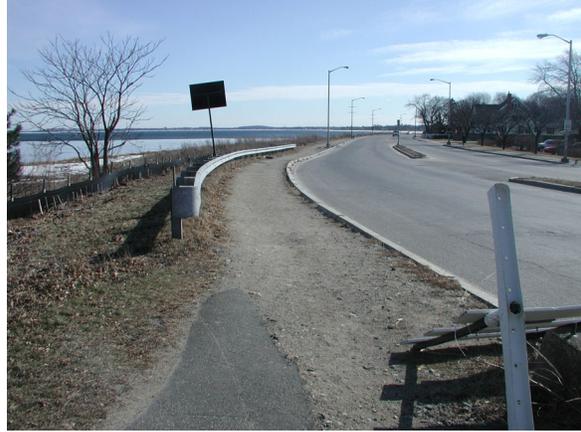
A short section of paved sidewalk leads through a pocket park at the northeast corner of the East Squantum Street/Quincy Shore Drive intersection. Benches and potential views to northeast invite visitors, but the intersection traffic and vegetation currently obscuring the views dissuade one from lingering. The paved path connects to a semi-maintained gravel sidewalk leading southeast along Quincy Shore Drive to Wollaston Beach.

Pocket park, viewed south along E. Squantum St. Gravel sidewalk towards Wollaston Beach.

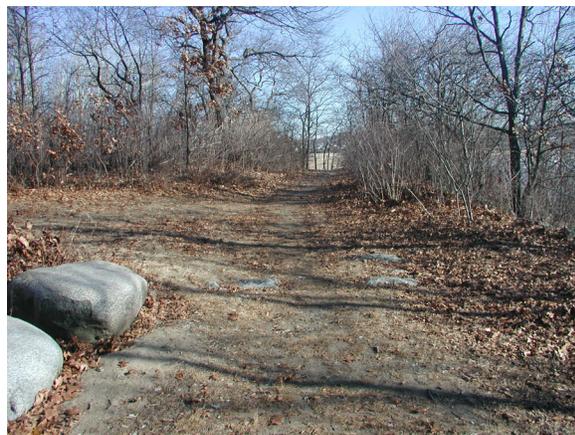
A dirt and gravel foot path averaging 5 feet wide leading north from the wooden bridge, or clockwise around the hummock. The north-facing point of the trail includes excellent views into the salt marsh to the north. A short, gently-sloped stretch leads to the east-facing section of the trail, with excellent view, from a higher viewpoint, into Boston Harbor.

View north on Section 7-2, east side of hummock

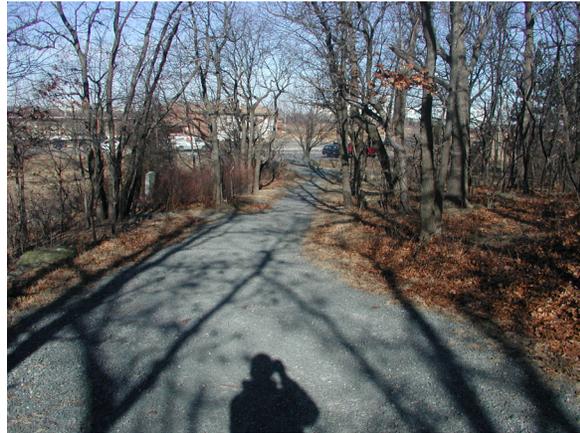
This section connects directly to section 7-2 and completes the Moswetuset Hummock loop back to the wooden bridge of 7-1 and the parking lot. This section is surfaced in gravel, is wider than 7-2, and slopes more gently to the east-facing section of the loop.

View along Section 7-3 towards parking area.

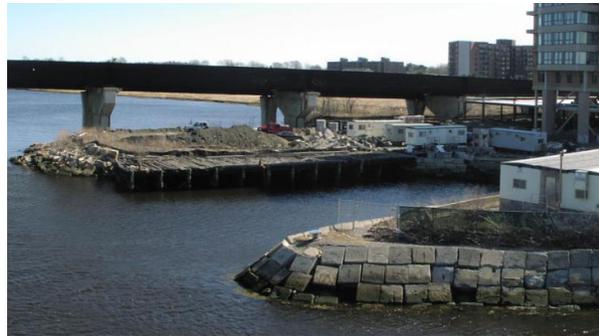
Wooden pier in Section 1-4, at left of center.

on this already heavily-impacted section of riverfront, use of the existing wooden pier on the north side of the slip may be preferable. Rehabilitation of this wooden pier, with a ramp to a floating dock, would involve less alteration of the armored bank and could provide the added benefit of an attractive riverside sitting and viewing area atop the pier and adjacent grassy area.

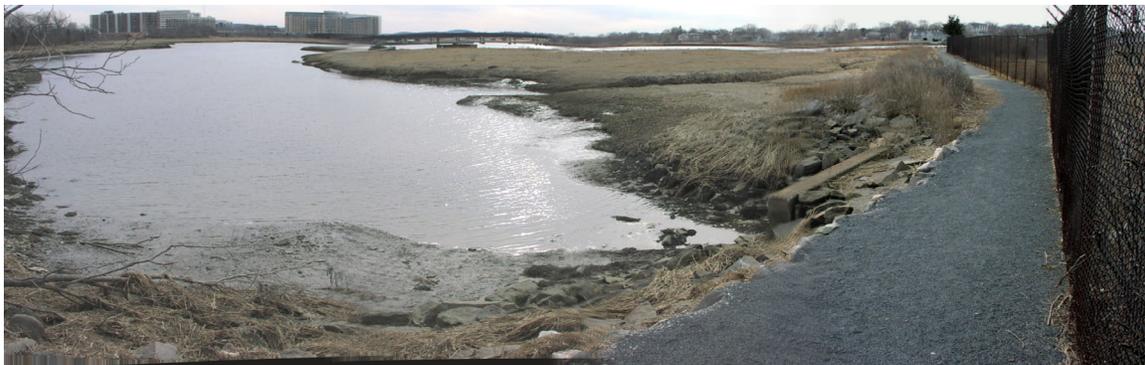
A fourth option is the estuary inlet adjacent to Commander O’Shea Boulevard, south of the Boston Scientific facility and trail Section 3-1. This location is very close to public parking, and the water is protected from wind and waves; however water depth would be an issue at low tides. A large culvert, most likely connected to the drainage system of the Boston Scientific parking lots, empties into this inlet. This land south of trail Section 3-1 appears to be part of the DCR Neponset River Reservation.

Estuary inlet south of Section 3-1.
