Hancock Cemetery

Master Conservation Plan

Quincy, Massachusetts

January, 2012

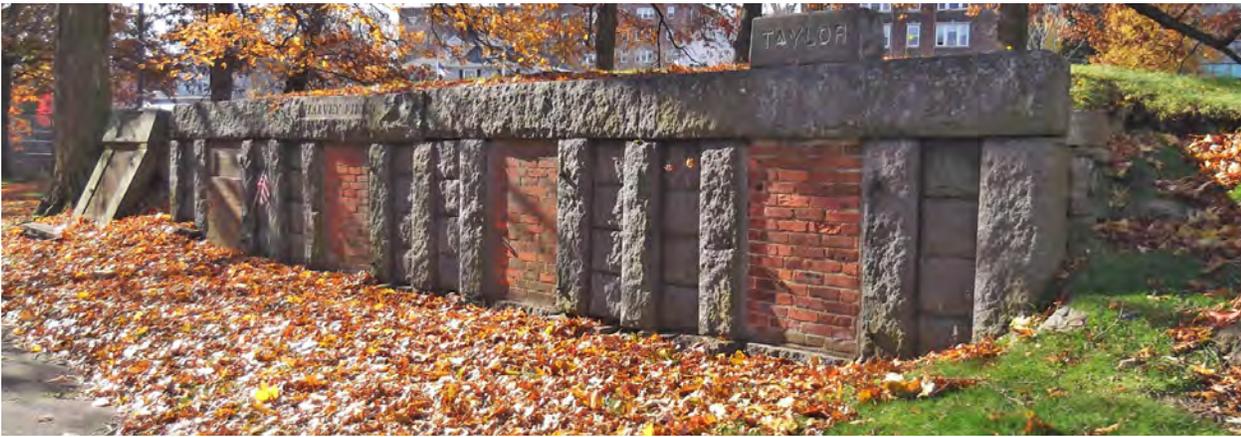
Mound tombs in the western part of the cemetery. (2011 photo)

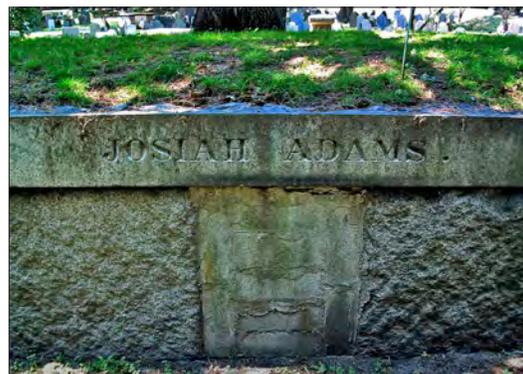
Tomb detail. (2011 photo)

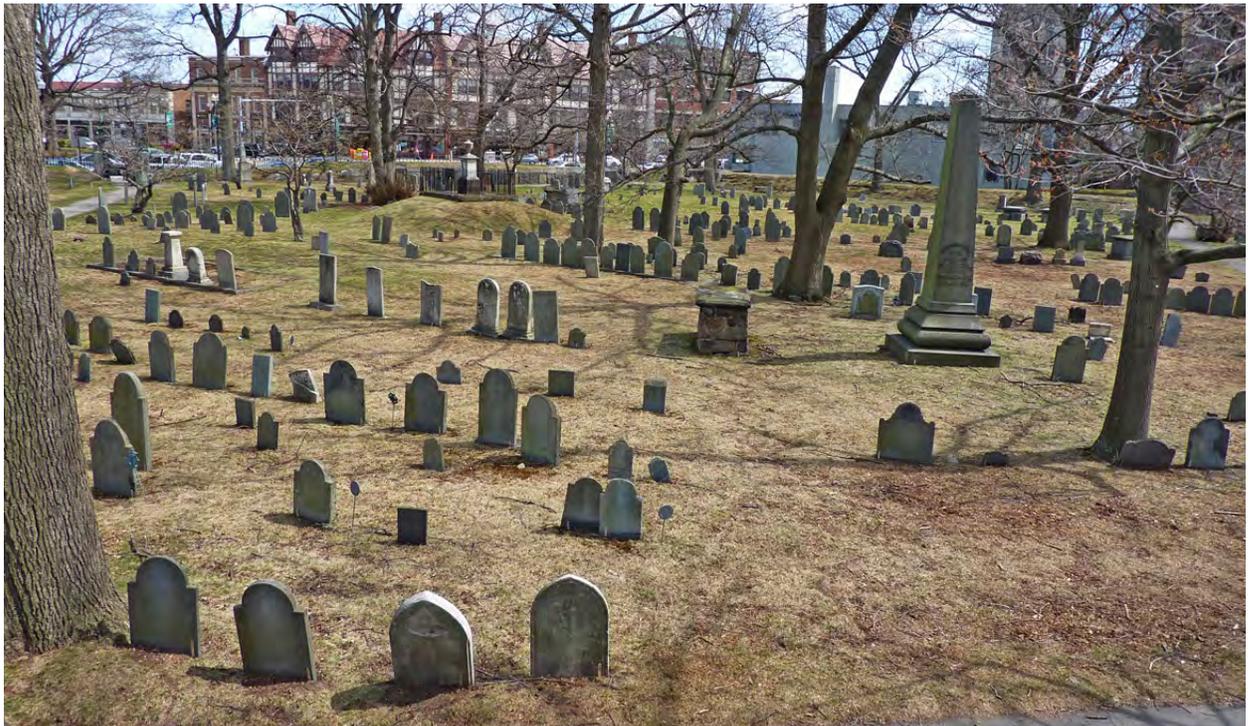
View of Hancock Cemetery in April 2011 after all memorials were given a unique survey number.

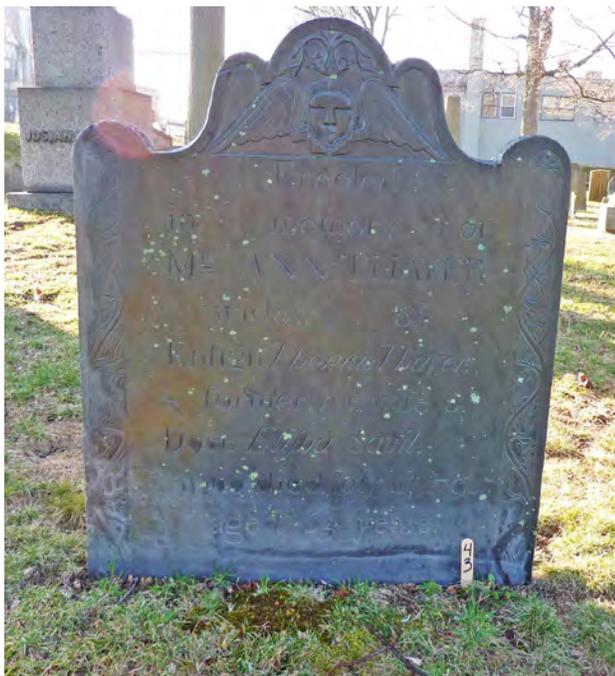
Slate slab marker for Map ID number 43. April 2011.

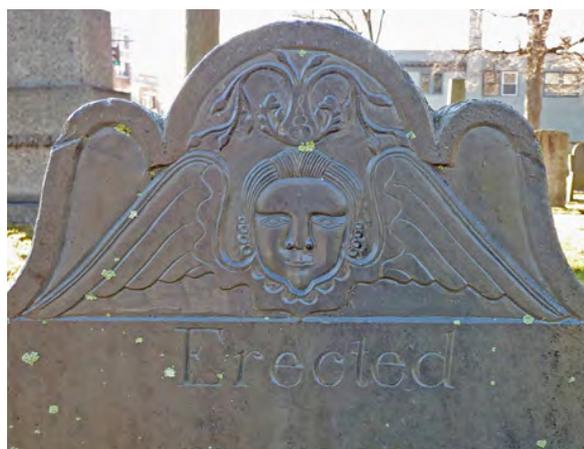
Detail of incised and relief carving for Map ID number 43. April 2011.

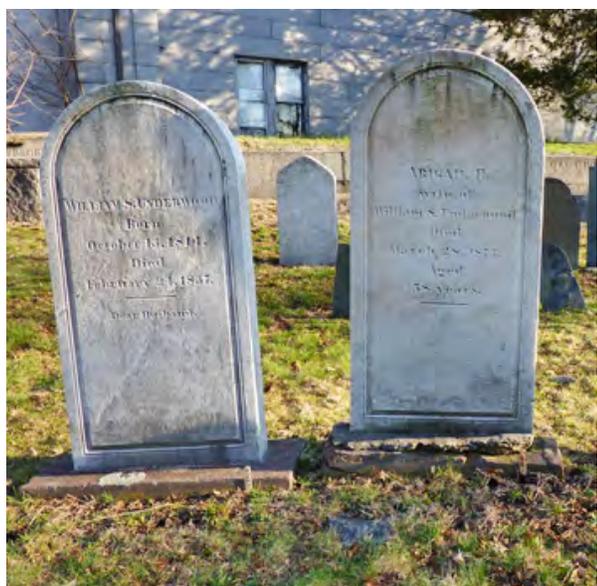
Marble slab markers Map IDs 37 and 38 set in slot bases. Note prior repair to slot base 37 with concrete. April 2011.

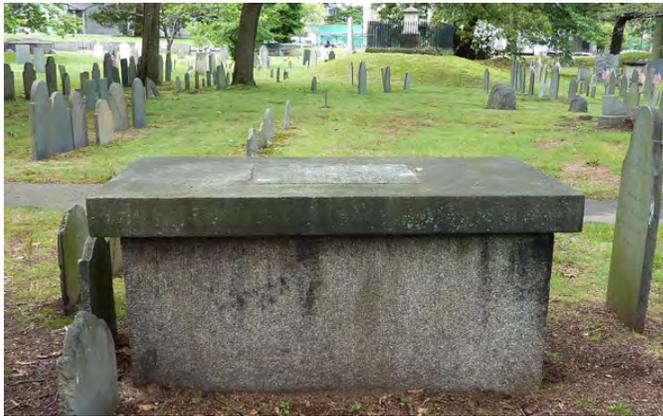
Granite tabletop monument . Map ID 870 April 2011

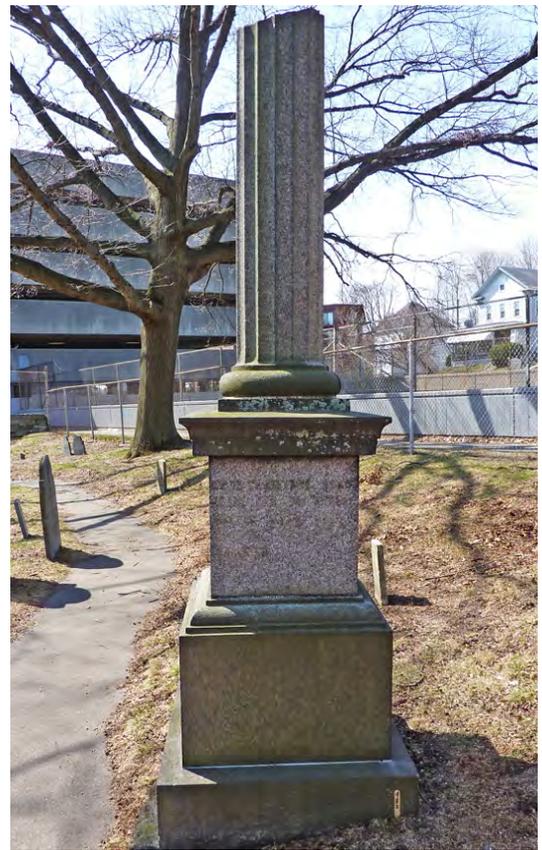
Large granite multi-part marker Map ID 982. April 2011.

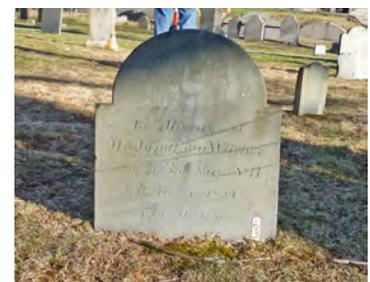
Slate slab Map ID 63, April 2011. The stone is tilting but not broken.

vulnerable to impact damage from mowers. A good case in point is map ID 63: slate slab headstone Wilcher, Jonathan, 1824, one of the stones repaired during the September 22nd workshop. [See pictures on the previous page.] When the inventory photographs were taken in April 2011, this stone was tilting (but intact) with surface cracks running horizontally across the face of it. In August 2011 when the condition assessment was completed, the stone was still tilting but now it was broken into three pieces, which, interestingly, did not follow the surface cracks that were still visible on the front of the stone.

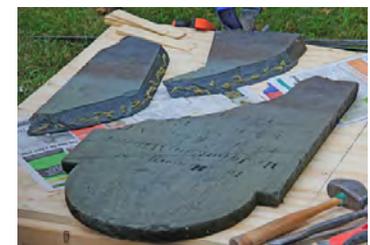
The same marker had broken into three pieces by the time of the September, 2011 training workshop.

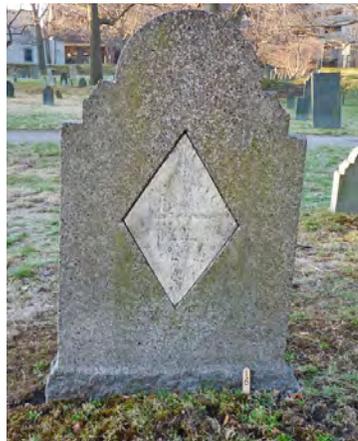
Granite slab Map ID 16 with inset marble plaque. April 2011.

Memorials with inserts fall into two subtly distinct categories: (a) granite-slab memorials with an original inset stone plaque [above left] and slate or marble memorials have been re-set into granite surrounds [above right]—a condition that qualifies as a prior repair. There are some prior repairs including stone surrounds and adhesive repairs

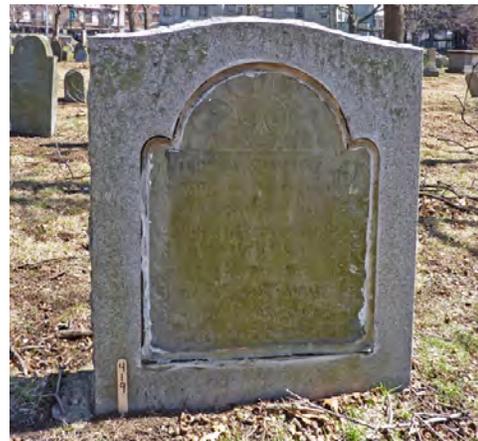
Slate slab Map ID 419 with granite surround; this prior repair needs maintenance to preserve the original headstone. April 2011.

Some of the granite surrounds and adhesive repairs require maintenance to extend the life of the treatment. In these cases it is more appropriate for the long term preservation of the memorial to do maintenance on the prior repair rather than reversing the prior repair and undertaking a new conservation treatment.

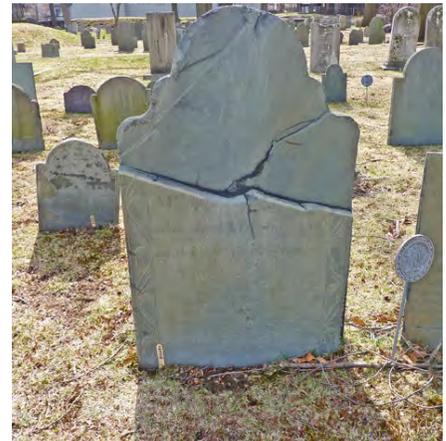
Slate slab Map ID 236 that has lost its inscription through delamination. April 2011.

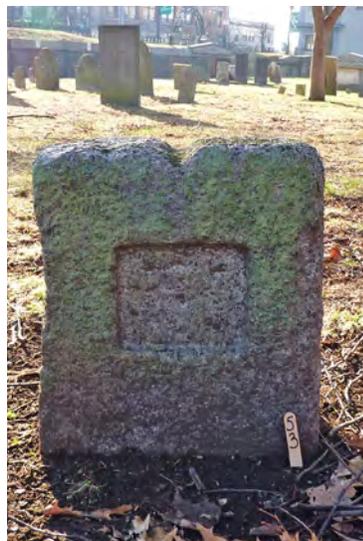
Granite slab Map ID 53 that has a missing inscription due to the loss of its inset plaque. April 2011.

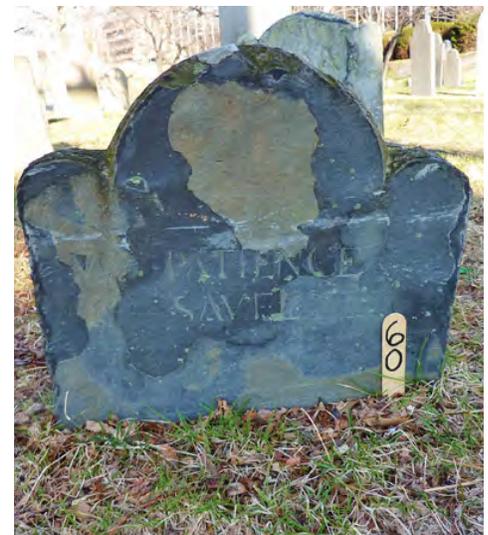
Slate slab (footstone) Map ID 60. Note mower scrapes and partial loss of inscription due to impact damage in addition to thin delamination. April 2011.

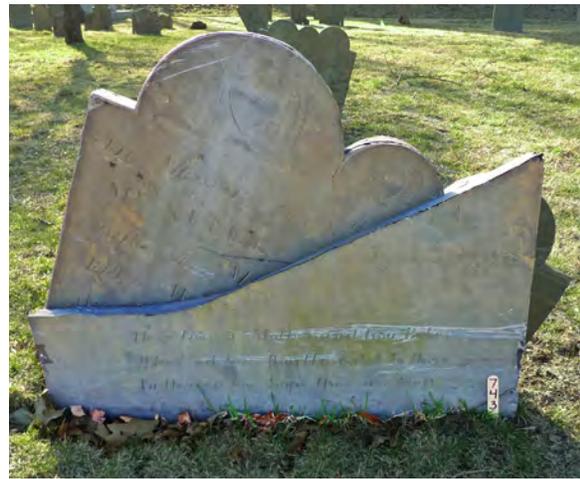
Slate slab Map ID 743. Wilson family headstone, with (apparently) a repairable break. April 2011.

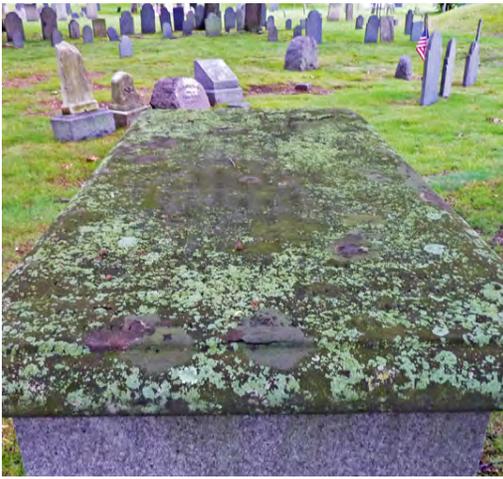
Brownstone and granite table top monument. Map ID 506. "The Ministers' Tomb." The brownstone top is at risk for delamination.

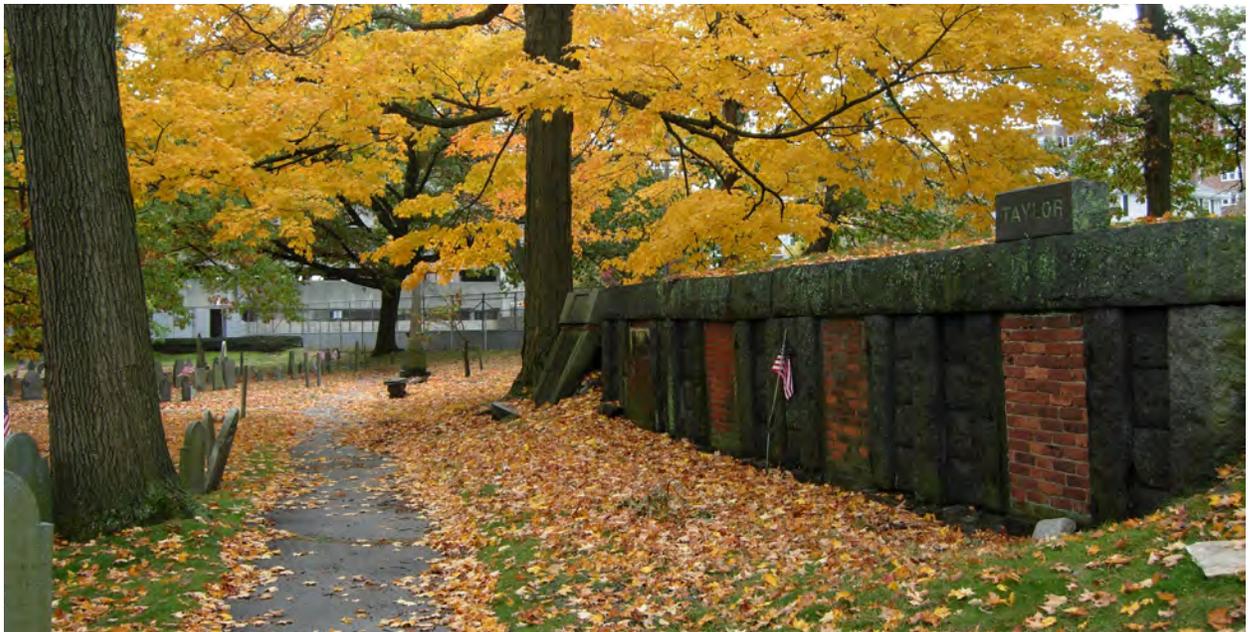
Linear arrangements of partially above-ground tombs are a significant character-defining feature of Hancock Cemetery.

The tombs in Hancock Cemetery are in good condition by and large. The principal issues for most of the tombs are related to deferred and very occasionally improper maintenance rather than to more severe issues such as outright masonry failure. The conditions that require treatment repeat themselves from tomb to tomb. Some tombs require more treatment than others but almost all of the tombs require one form of maintenance or another.

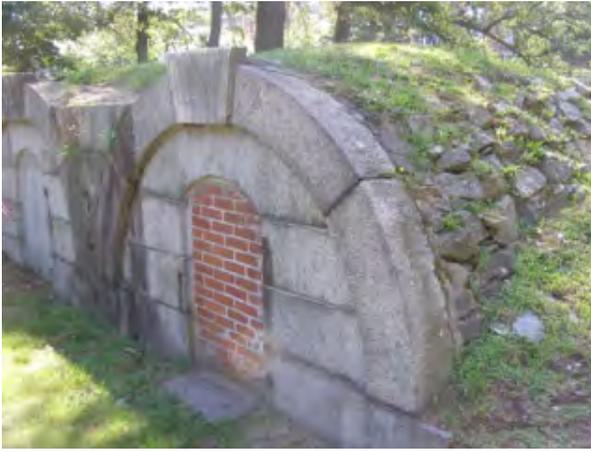
Side by side barrel vault tombs with the granite blocks that form the vault exposed because of soil erosion. Note "V" shaped retaining wall at front to keep the soil between the vaults from eroding forward. Also note cement wash applied to the interface between the front wall and the vault.

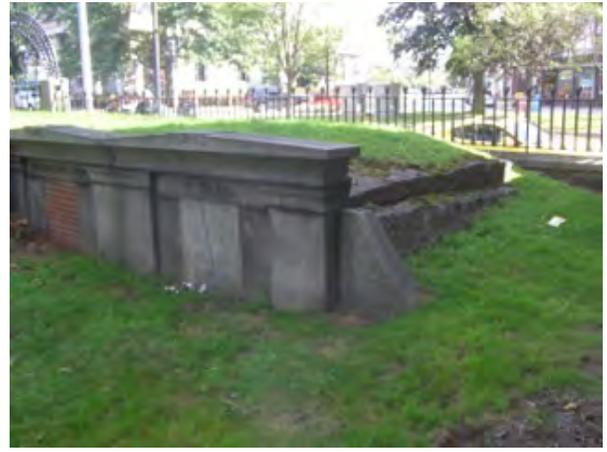
Tomb with flat roof formed by slabs of granite. Note parapet in front to retain soil as well as retaining wall on the right side of the front wall.

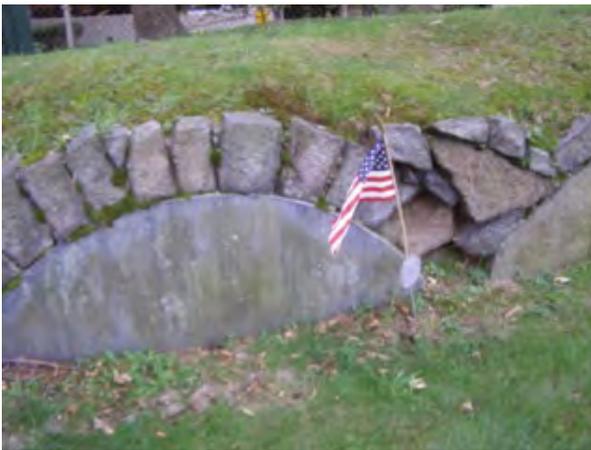
Side by side barrel vault tombs with a front consisting of a single granite slab. Note retaining wall on top of the front wall slab as well as retaining wall in the valley between the tombs.

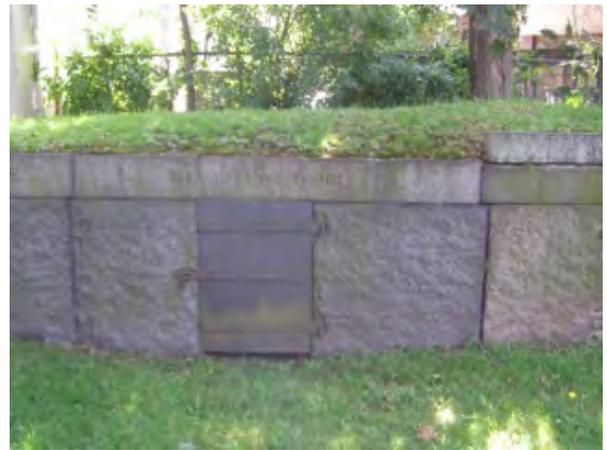
Retaining tomb with flat slab roof and two granite slabs with serving as the front wall. Iron door may possibly be original. Note additional course of stone on adjacent tomb that serves as a retaining wall to hold the soil cover.

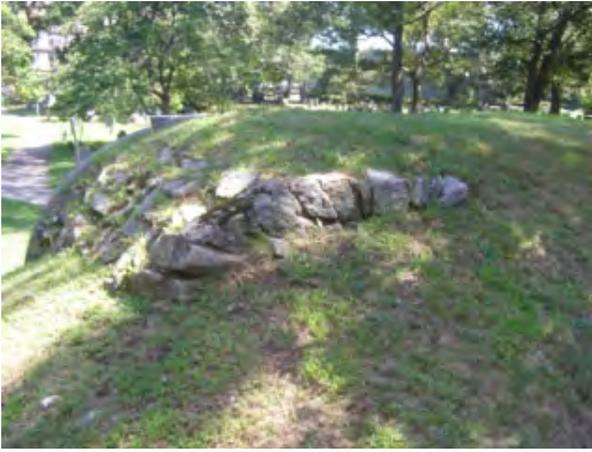
View of exposed rear wall of a barrel vault tomb. Note that rear wall stones have been worked to form an arch. The erosion of the soil cover over the tomb is resulting in the displacement of the rear wall stones.

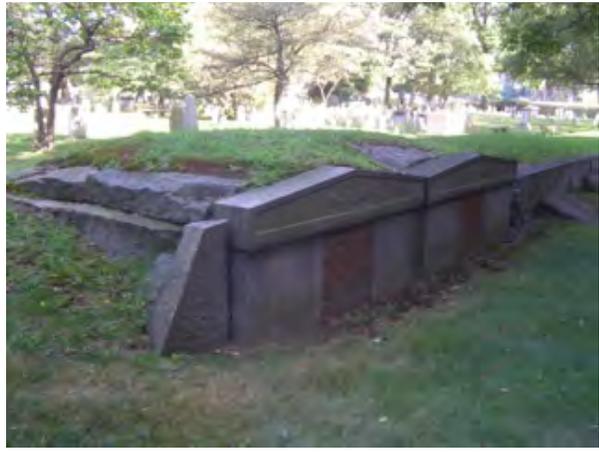
Tomb with flat roof formed from granite slabs placed on sidewalls that are also granite slabs instead of granite rubble. Note pediment that serves as retaining wall for soil and the small retaining wall on the left side of the front wall.

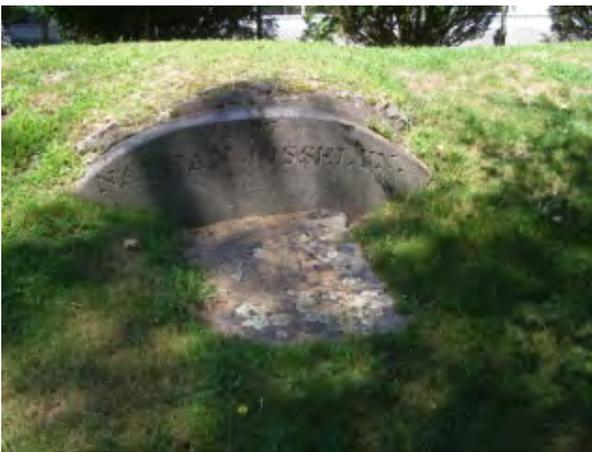
Tomb with barrel vault and front consisting of a single granite slab. Note slab covering entrance at grade. The placement of the entrance cover directly against the front wall slab helps to stabilize the front wall. Also note cement wash between front wall and vault.

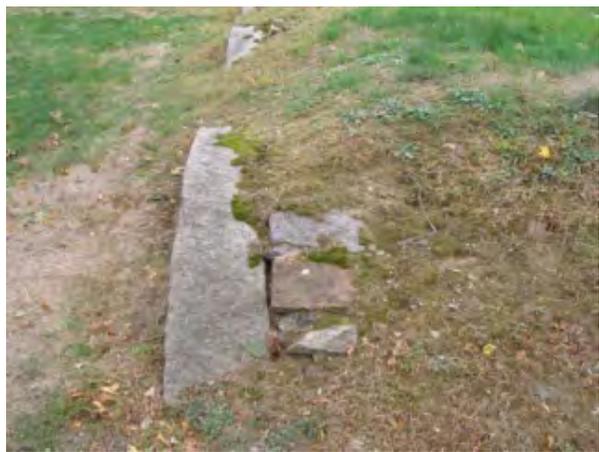
Row of low tombs with single slab fronts. Note the mounds of soil that are forward of the line of the tombs fronts. This may be intentional or the result of erosion due to the lack of retaining walls in the valleys between the tombs.

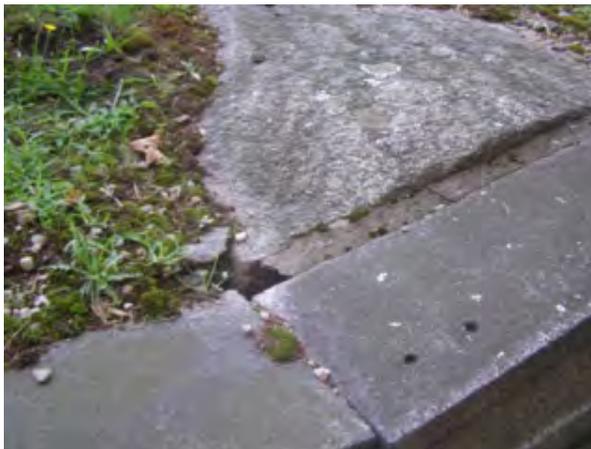
Detail of sifted front wall with failing cement in the joint between the front wall and the flat granite slab roof.

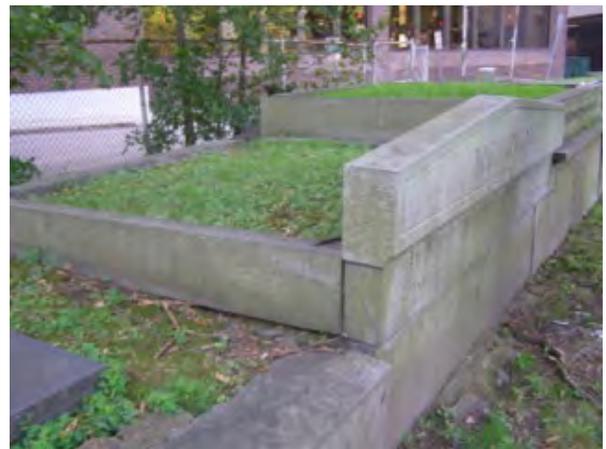
One of three tombs with low walls on top of the tomb constructed from granite slabs – possibly to function as a planting bed.

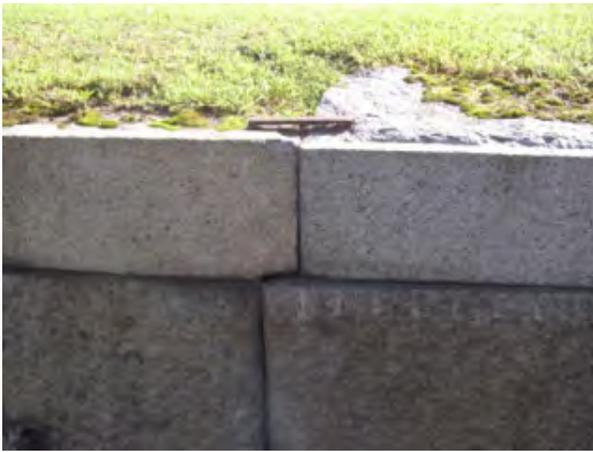
Lateral iron anchor placed between the front wall units of adjoining tombs to help restrain the walls from moving.

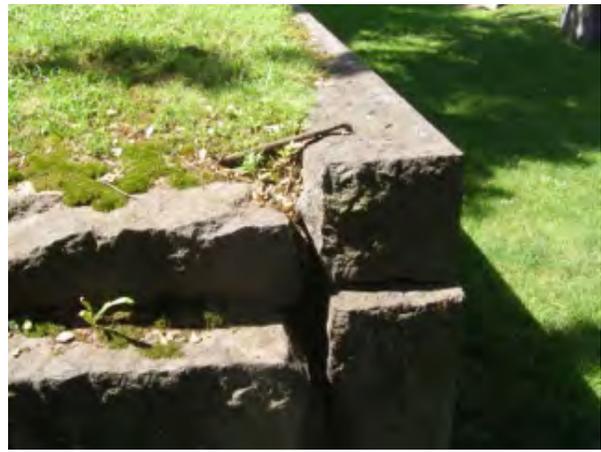
Exposed iron anchor placed between the front wall and the flat granite roof slab to keep the front wall from tilting forward.

The massive pieces of granite that form the front walls were set in front of the granite roof slabs rather than under them. This was done so that the front wall could be constructed six to eight inches above the roof thereby acting as a barrier to keep soil on the roof in place.

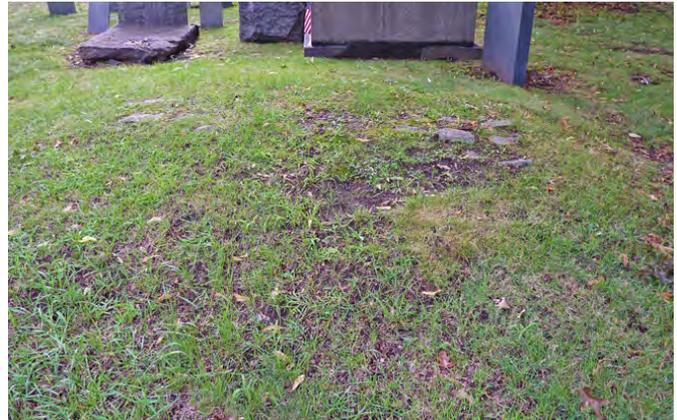
This unmarked subterranean tomb has partially lost its covering layer of soil and grass, leading to potential damage to the vaulted roof.

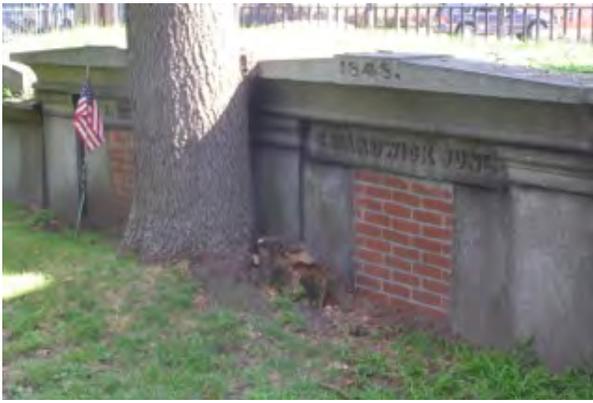
Mature tree pressing against the front walls of a row of tombs resulting in the displacement of the front wall units. Roots of tree may also be undermining the integrity of the foundations.

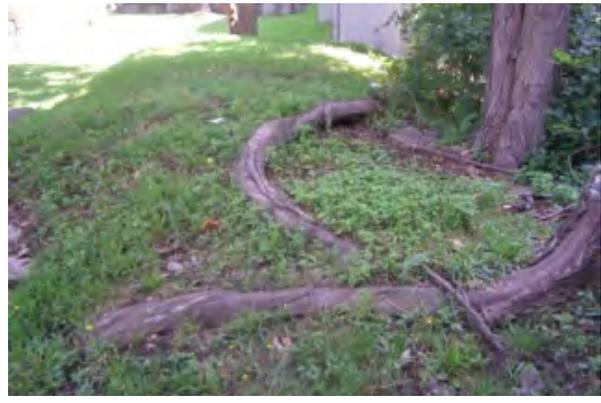
Detail of tree roots growing over the top of a flat slab tomb. Tree appears to have grown opportunistically in the untended area behind the tombs.

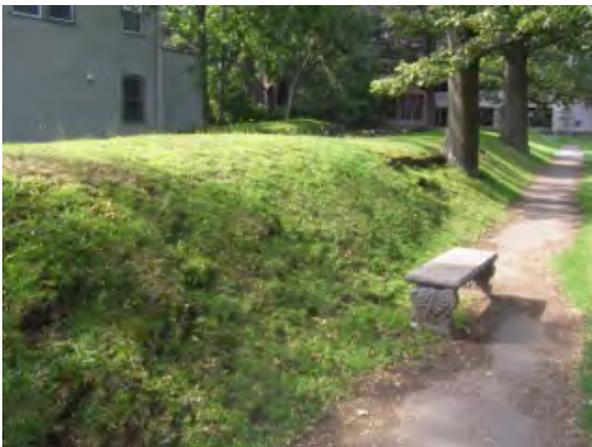
Two trees growing in the soil cover behind the rear walls of a line of tombs. Roots from these trees may be undermining the integrity of the foundations or rear walls of the tombs.

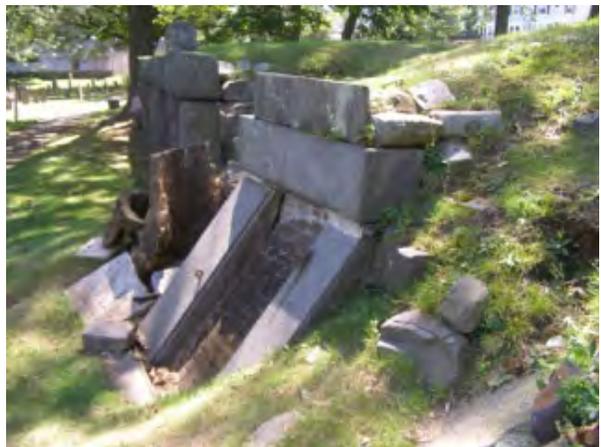
Displacement and near collapse of the front wall of a tomb caused by the growth of a large tree adjacent to the front wall. Tree has been felled but only after the growth of the tree caused substantial damage.

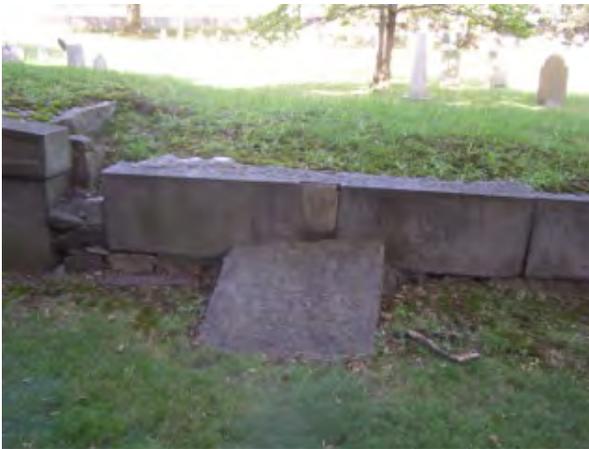
Low tomb with granite slab front and entrance slab. Note lack of retaining wall between this tomb and the one of the left. Also note the makeshift repairs at the base of the slab after the front slab began to move.

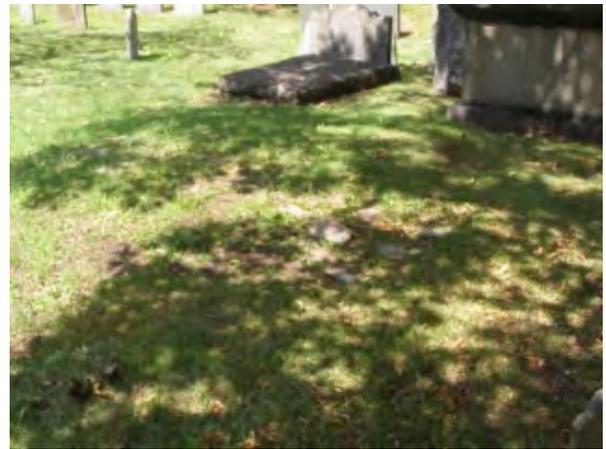
Partially exposed vault roof of a subterranean tomb. Replacement of the soil cover is recommended to help stabilize the tomb.

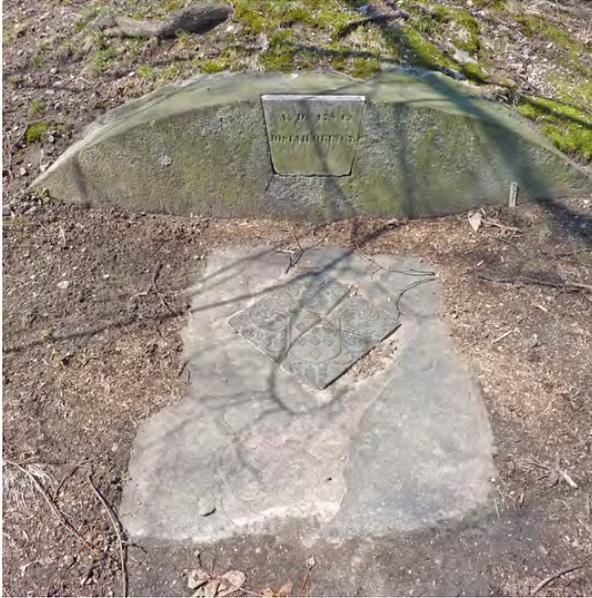
Low tomb with granite slab front and slate tomb cover. Note diamond shaped slate inset panel.

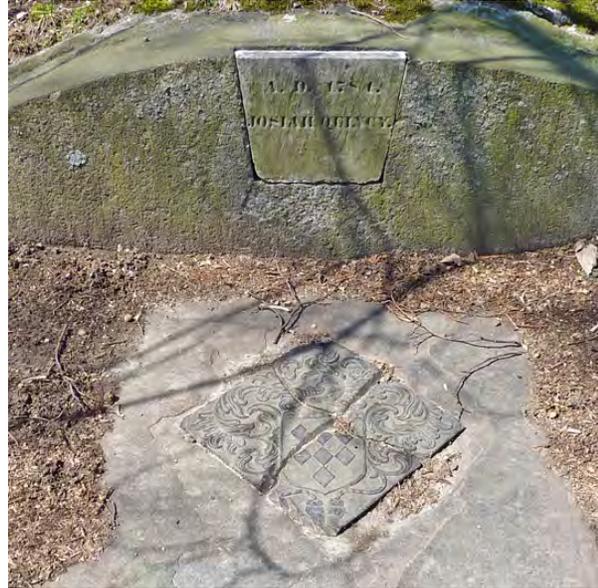
Detail of diamond shaped slate inset panel with carvings. Inset panel was probably imported and set in a slab of domestic slate. The inset panel is cracked and requires treatment.

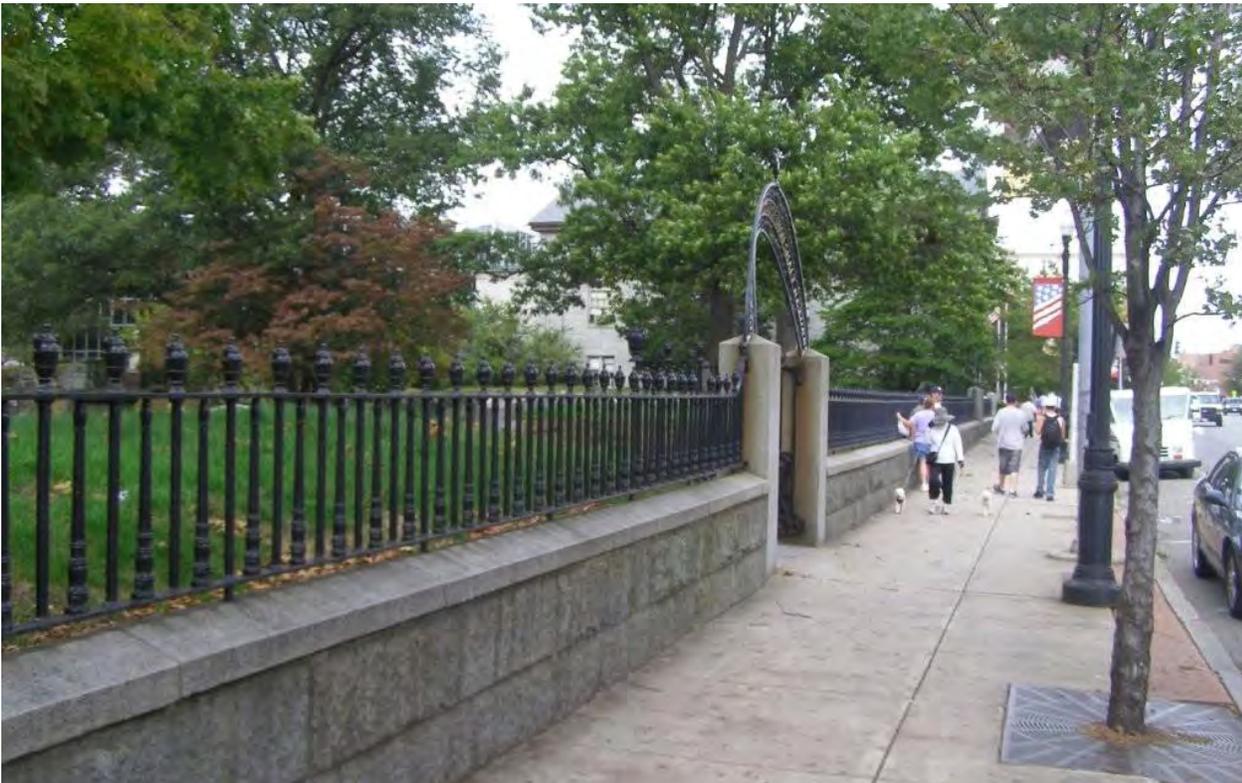
Hancock Street wall and cast iron fence. Note film of biological growths on wall and rust stains on granite posts where cast iron arch connects to granite.

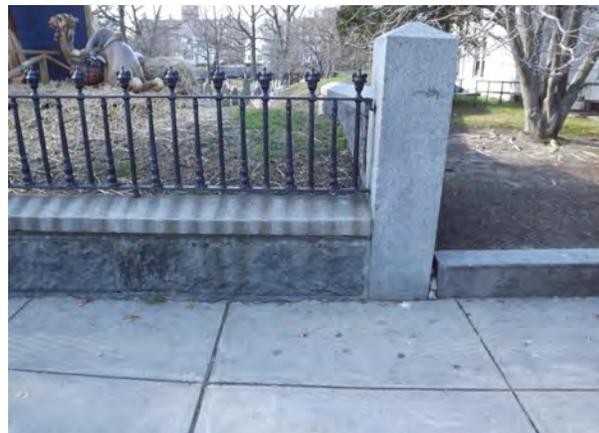
Northern end of Hancock Street wall and fence with section of western wall..

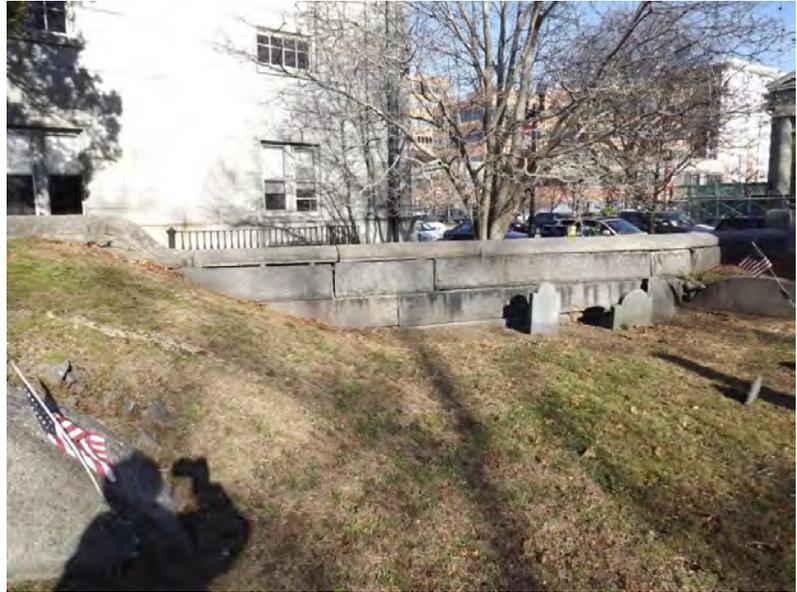
Eastern end of granite wall between cemetery and City Hall. Note shaped coping stone at change of grade as well as switch to smaller fragments of stone where wall disappears behind tombs.

These three stone walls are in good condition and, at present, only the wall along the boundary with City Hall requires some resetting work. The cavity that is part of the original construction makes the facing stones vulnerable to displacement from ice jacking. Water that enters the wall through open joints between the coping stones freezes in the winter—the expansion of the water as it turns into ice is responsible for the displacement. Correcting the problem requires removing the coping stones as well as the shifted facing stones and then resetting them. It may be possible to insert some mechanical anchors in the form of stainless steel pins to keep the wall from shifting in the future.

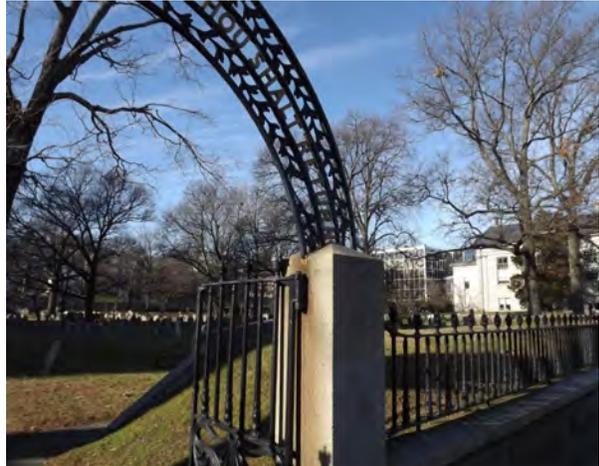
Section of southern entryway with cast iron gate and arch set into granite post

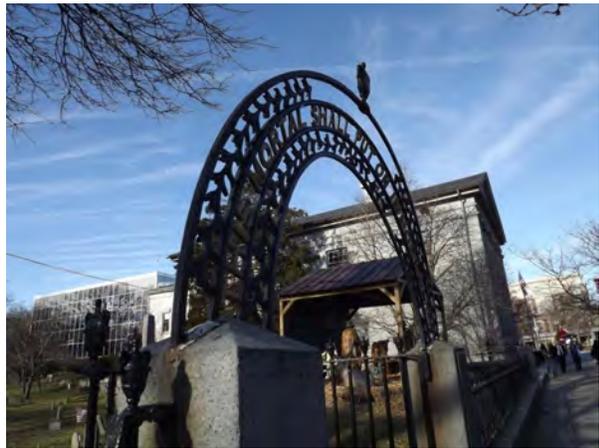
Northern entry arch. Note missing oak and acorn pattern at top and bottom bands.

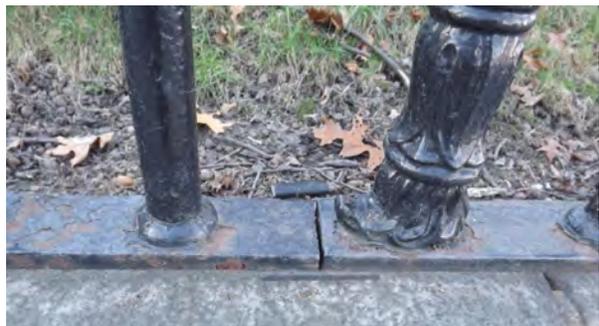
Detail of failing paint at lower rail of Hancock Street fence as well as recess for water created by weld plate installed between sections of the lower rail.

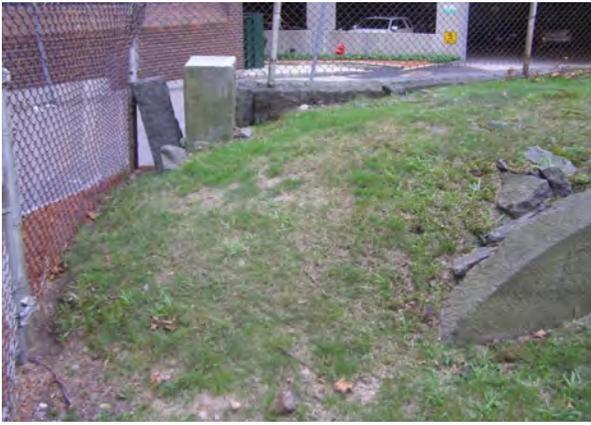
Southern terminus of rail road wall with leaning granite posts and holes in granite where an earlier iron fence was removed.

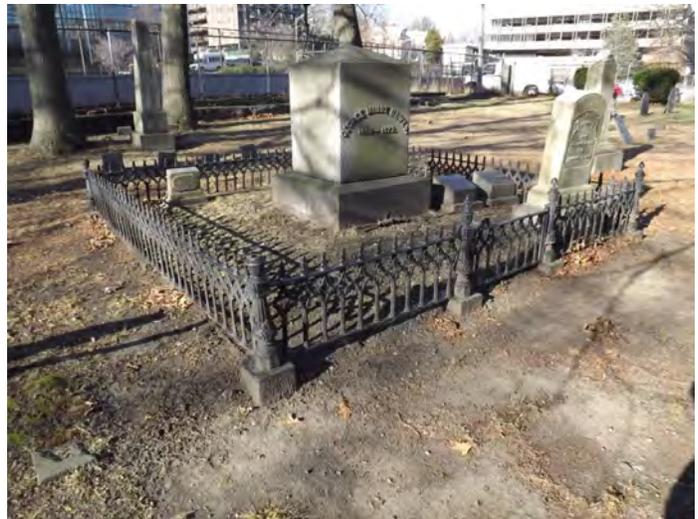
Cast iron family plot fence set on buried granite posts. Note missing corner finials and exposed tops of corner posts.

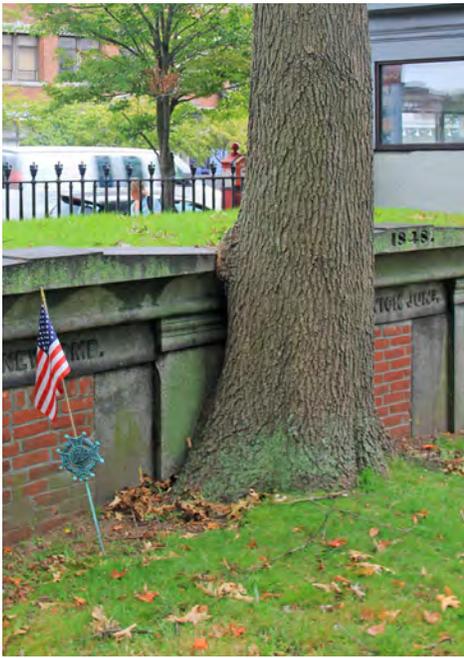
This mature oak growth, shown on the left, is damaging a burial vault and will require removal; this is a Priority 1 tree impacting the cemetery's burial vaults.

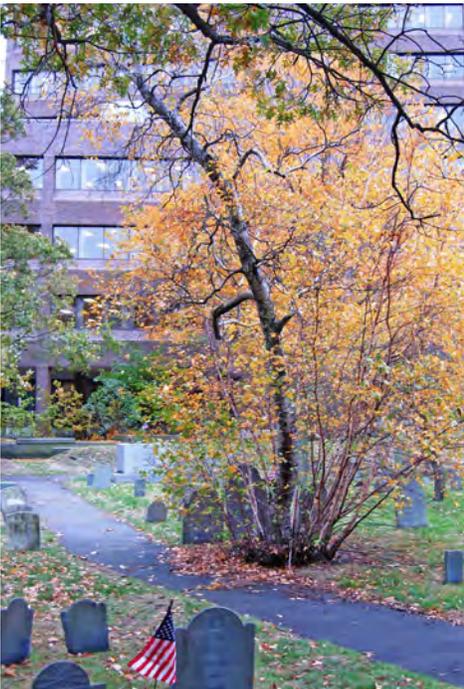
The birch stump (left) does not contribute to the overall character of the cemetery and should be removed; this is a Priority 2 tree.

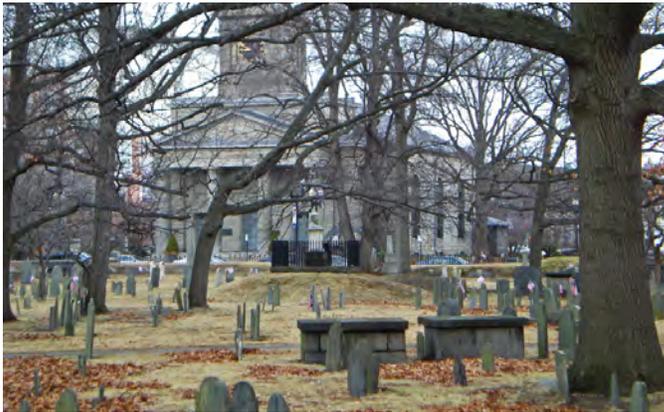
When lateral and hanging branches break, serious damage to memorials can occur.

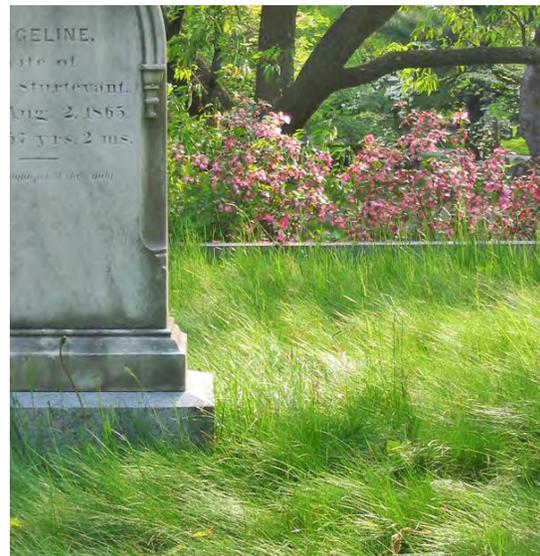
High fescue grasses used on low- traffic areas at Mount Auburn Cemetery.

While the turf at Hancock Cemetery appears to be well maintained and in good condition, consideration should be given to the use of higher fescue grasses in areas where foot traffic is to be discouraged—particularly over the tops of mound tombs. Fescue grasses are more drought and shade tolerant than blue grass lawns and can be allowed to grow taller in keeping with the historic character of the cemetery. This longer, less-often-mowed grass approach has been implemented with success in selected locations at Mount Auburn Cemetery in Cambridge.

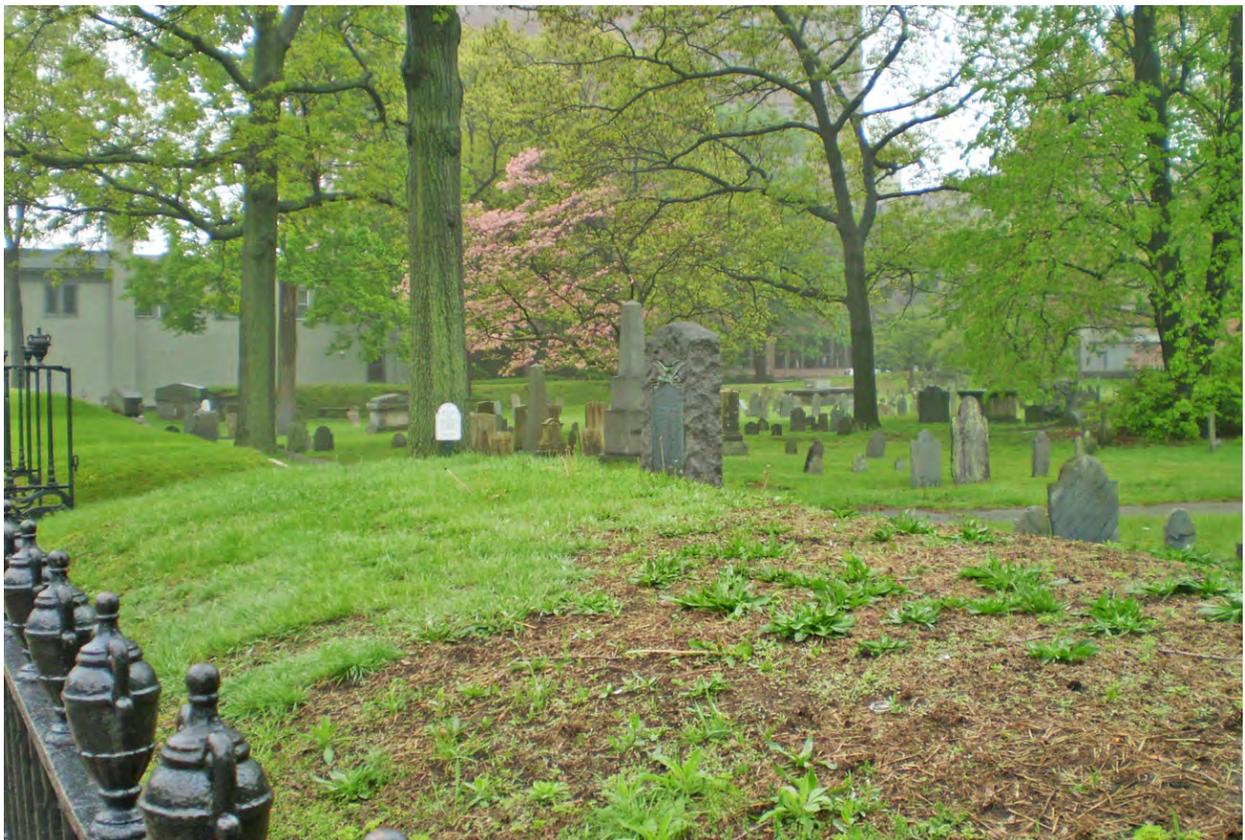
Deterioration of turf on area protecting tomb vaults along Hancock Street.
