ADDENDUM NUMBER 4

BID TITLE: **Demolition of old Quincy High School**

RE: Hazardous Material Survey Report
Old Quincy High School
65 Coddington Street Quincy, Massachusetts

HAZARDOUS MATERIAL SURVEY REPORT

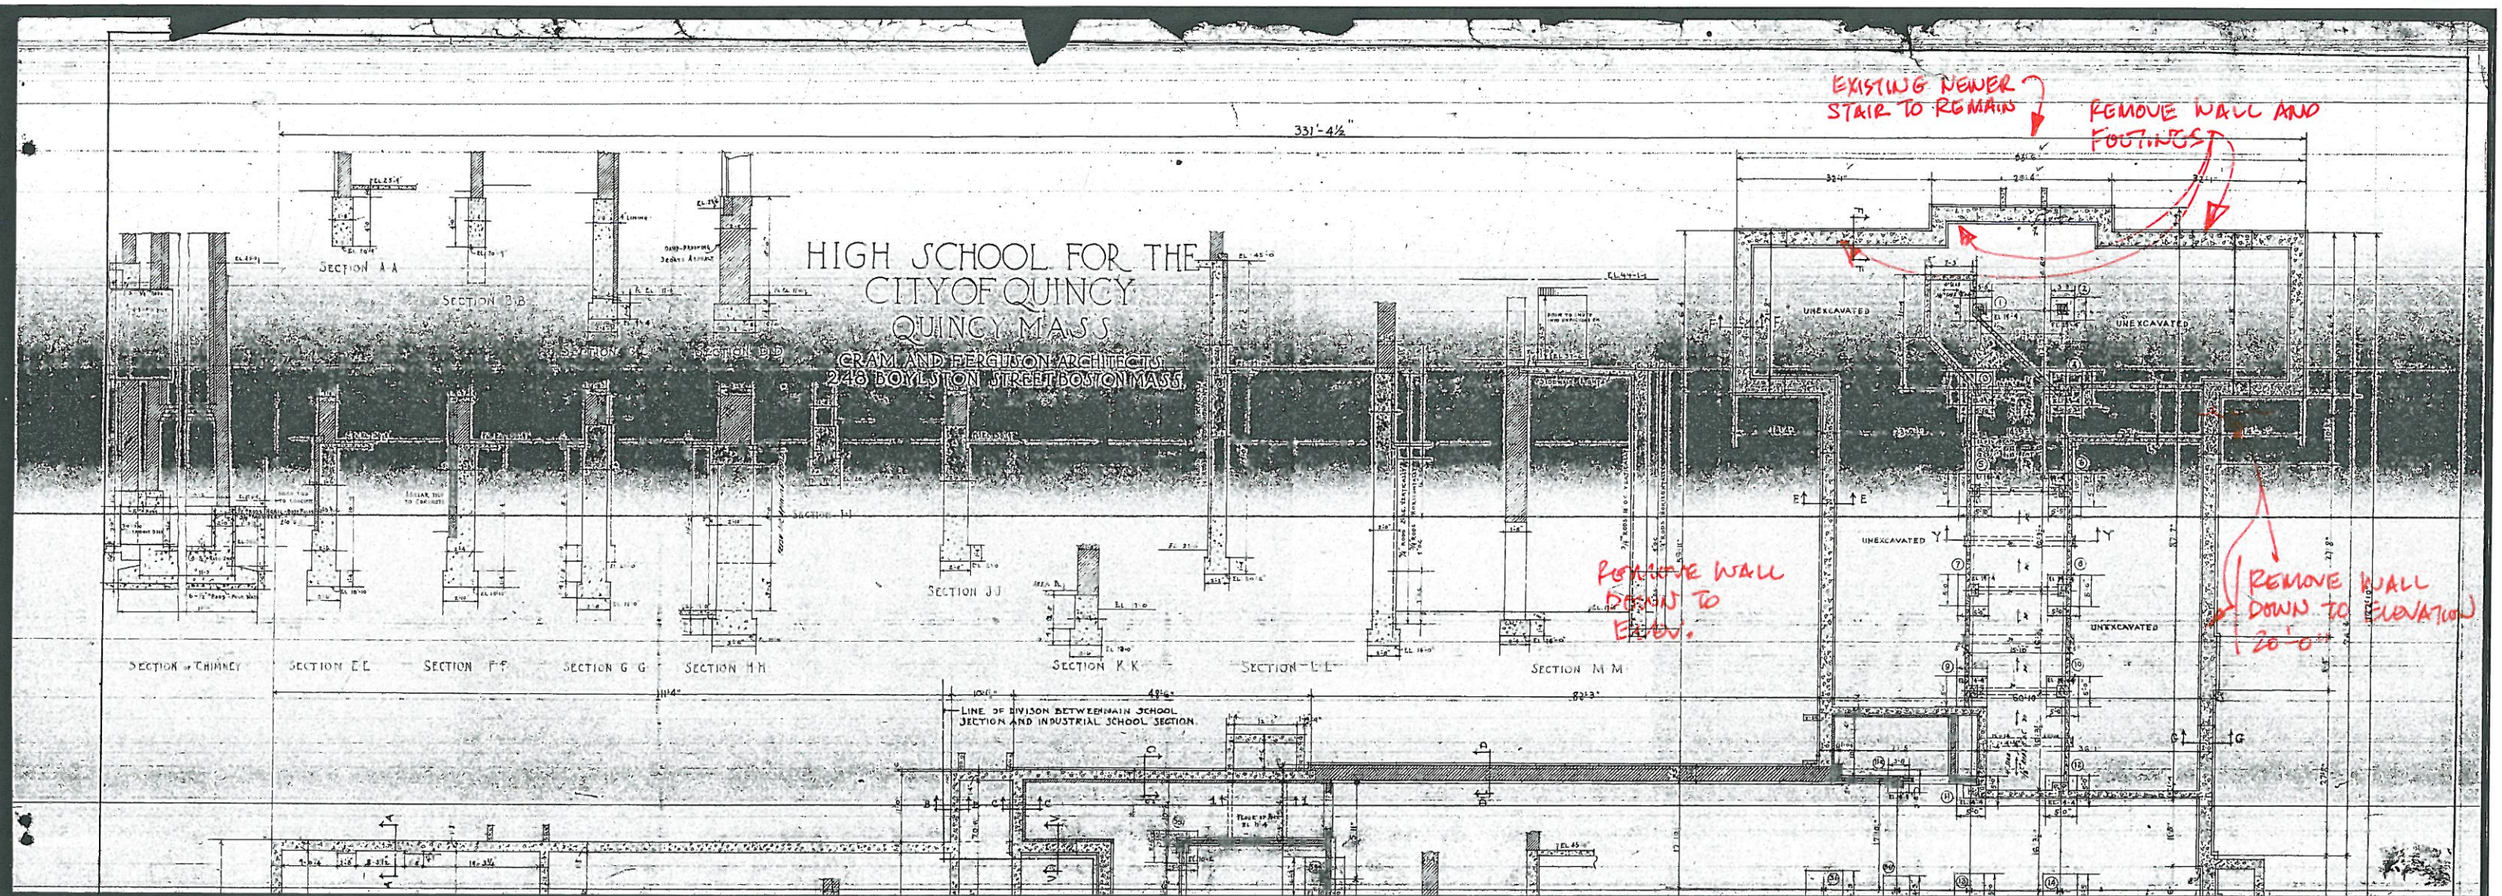
2A

HIGH SCHOOL FOR THE
CITY OF QUINCY
QUINCY, MASS.
CRAM AND FERGUSON ARCHITECTS
248 BOYLSTON STREET BOSTON MASS.
331'-4½"
SECTION A A
SECTION B B
SECTION J J
SECTION K K
SECTION M M
SECTION CHIMNEY
SECTION E E
SECTION F F
SECTION G G
SECTION H H
LINE OF DIVISON BETWEEN MAIN SCHOOL SECTION AND INDUSTRIAL SCHOOL SECTION.
UNEXCAVATED
EXISTING NEWER STAIR TO REMAIN
REMOVE WALL AND FOOTINGS
REMOVE WALL DOWN TO ELEV.
REMOVE WALL DOWN TO ELEVATION 20'-0"

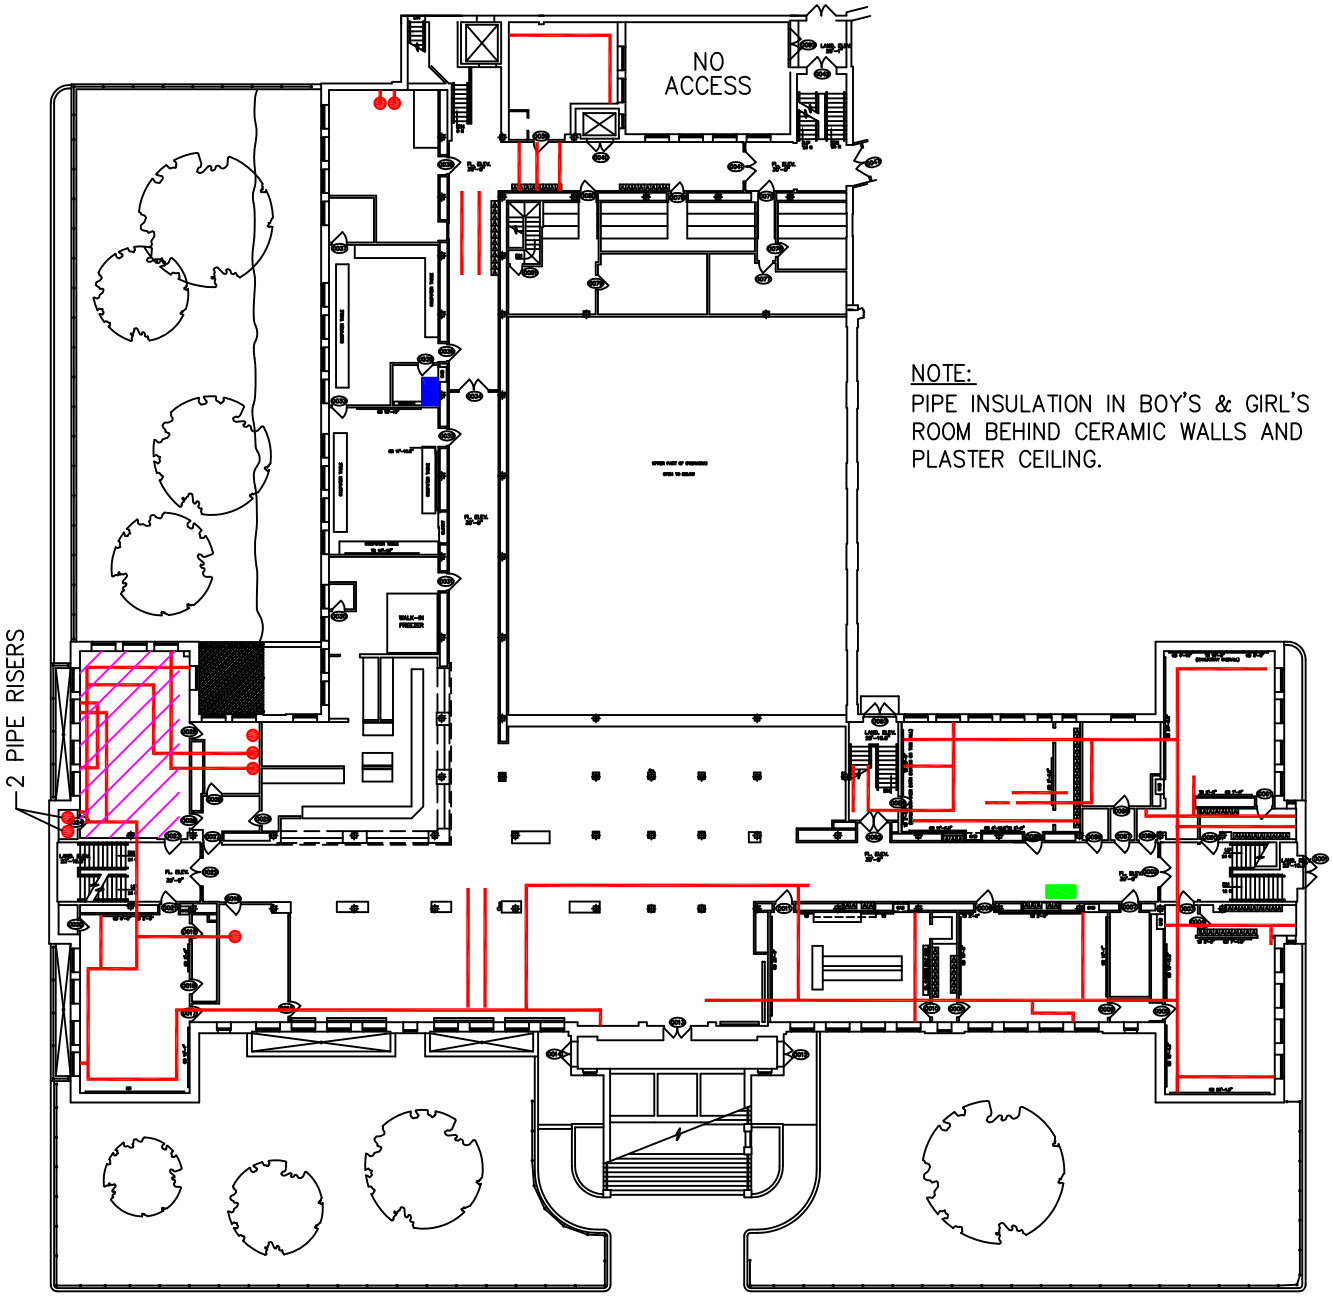
DATE: 9/6/11 **TSI-2** SHEET 2 OF 6	ASBESTOS-CONTAINING MATERIAL LOCATIONS	PROJECT NO. 1076.728 DWN. BY T.M.	OLD QUINCY HIGH SCHOOL GROUND FLOOR	esis ESIS, INC. - HEALTH, SAFETY & ENVIRONMENTAL SERVICES	CITY OF QUINCY PUBLIC BUILDINGS DEPT. 1305 HANCOCK STREET QUINCY, MA 02169

NOTE:
PIPE INSULATION IN BOY'S & GIRL'S ROOM BEHIND CERAMIC WALLS AND PLASTER CEILING.

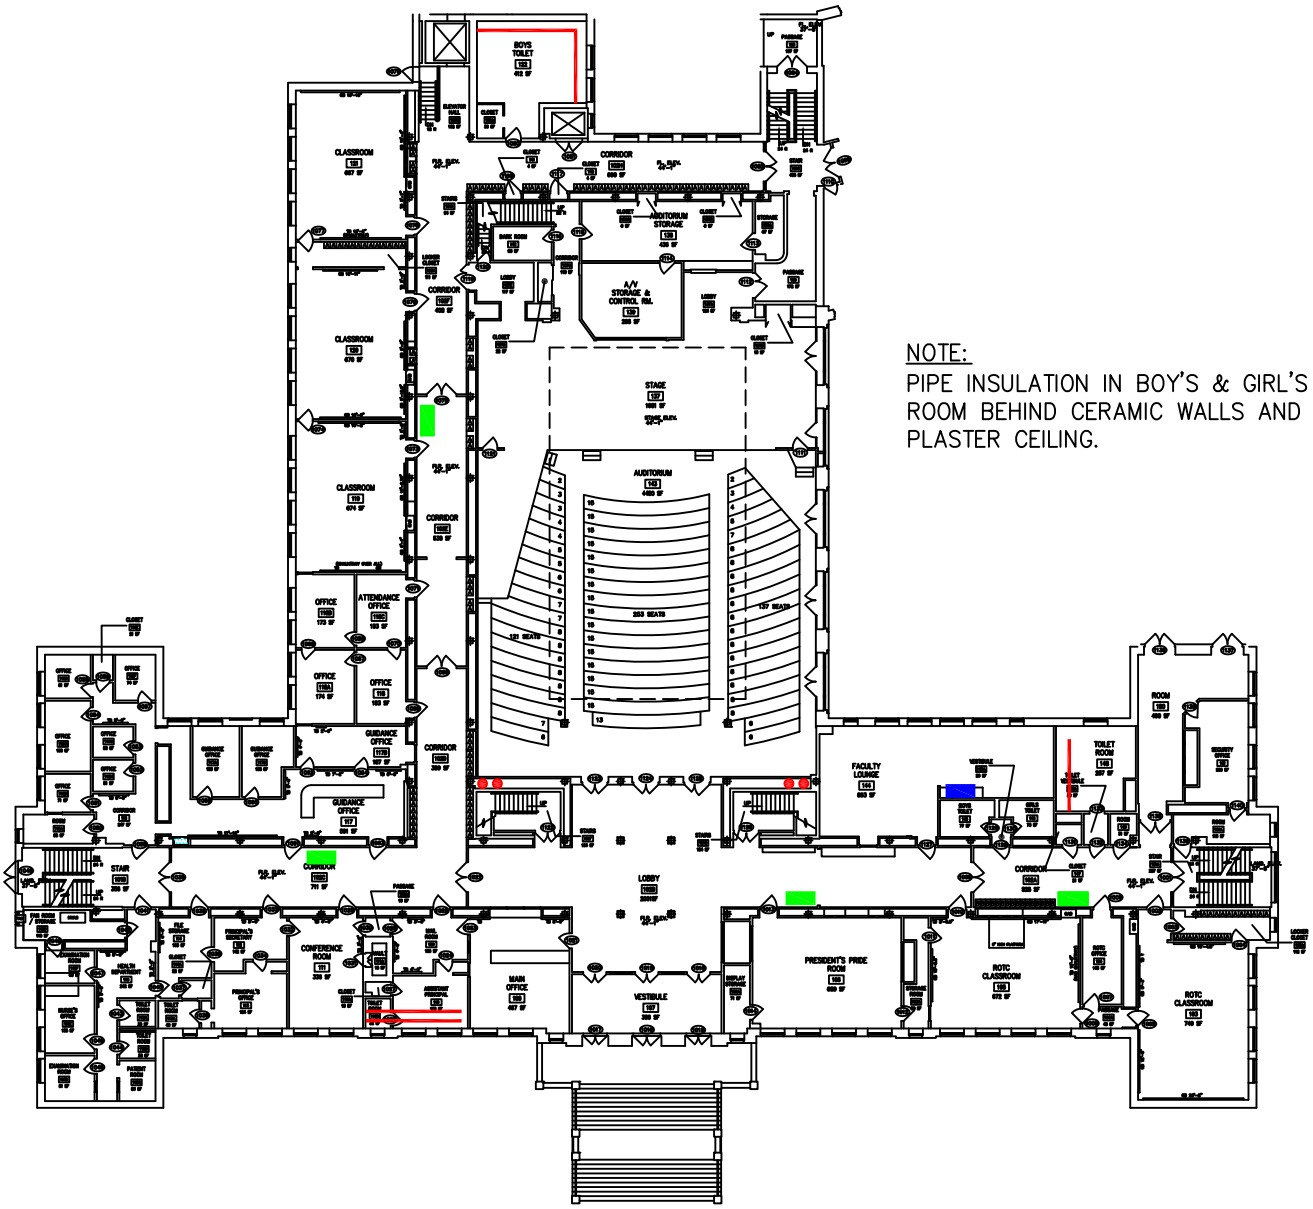
DATE: 9/6/11 **TSI-3** SHEET 3 OF 6	ASBESTOS-CONTAINING MATERIAL LOCATIONS	PROJECT NO. 1076.728 DRN. BY T.M.	OLD QUINCY HIGH SCHOOL FIRST FLOOR	esis ESIS, INC. - HEALTH, SAFETY & ENVIRONMENTAL SERVICES	CITY OF QUINCY PUBLIC BUILDINGS DEPT. 1305 HANCOCK STREET QUINCY, MA 02169

NOTE:
PIPE INSULATION IN BOY'S & GIRL'S ROOM BEHIND CERAMIC WALLS AND PLASTER CEILING.

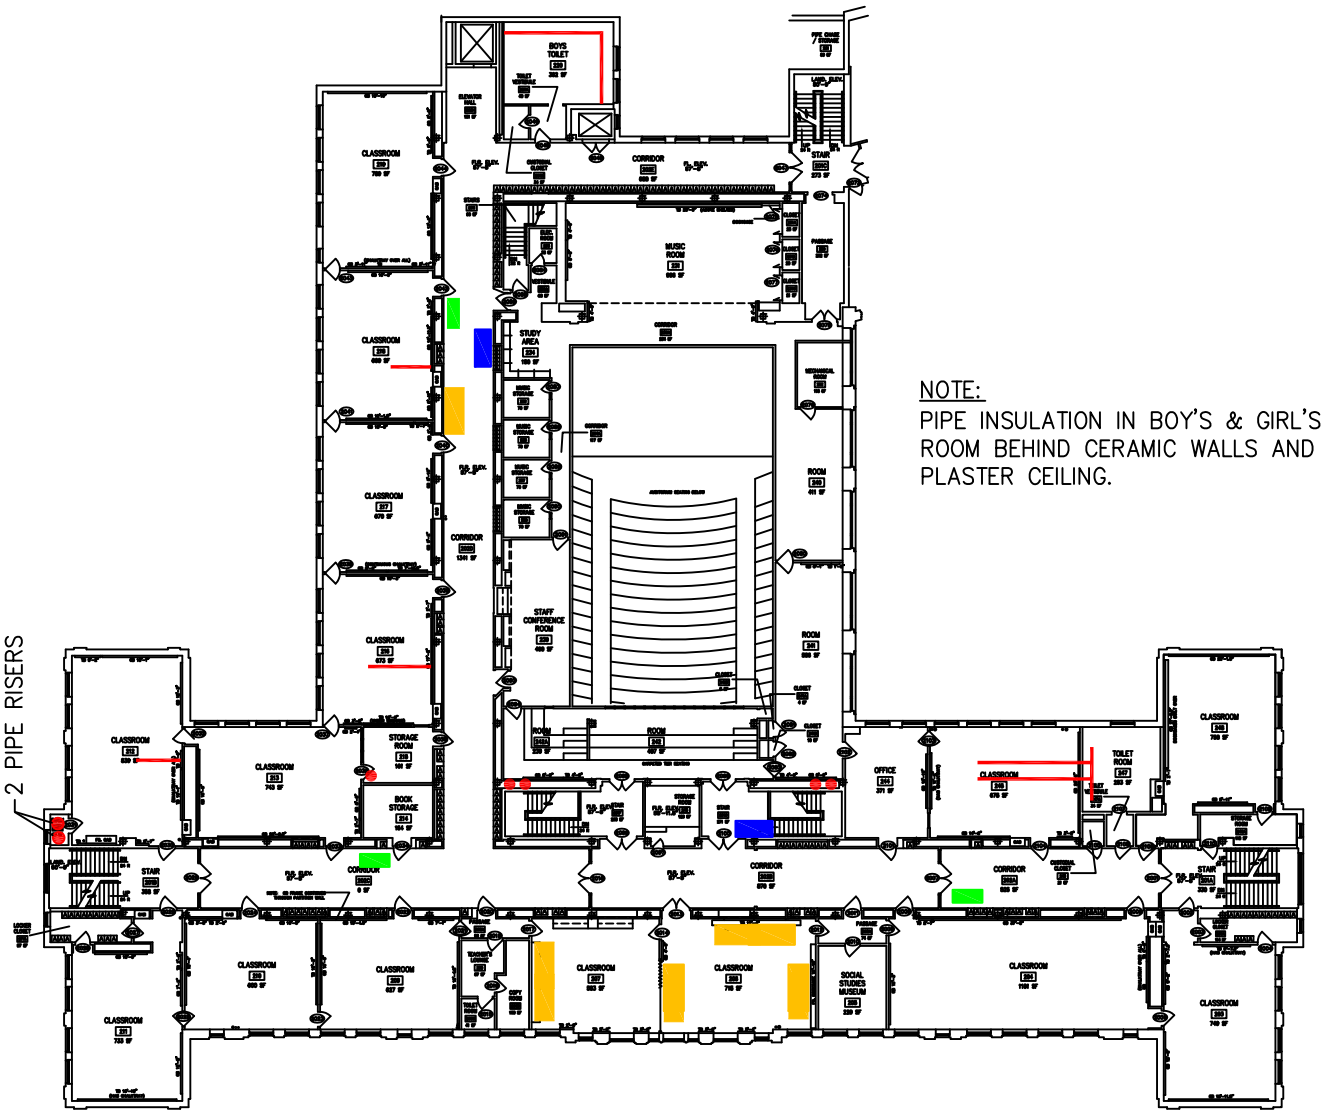
DATE: 9/6/11 **TSI-4** SHEET 4 OF 6	ASBESTOS-CONTAINING MATERIAL LOCATIONS	PROJECT NO. 1076.728 DRL BY T.M.	OLD QUINCY HIGH SCHOOL GROUND FLOOR	ESIS, INC. - HEALTH, SAFETY & ENVIRONMENTAL SERVICES	CITY OF QUINCY PUBLIC BUILDINGS DEPT. 1305 HANCOCK STREET QUINCY, MA 02169

NOTE:
PIPE INSULATION IN BOY'S & GIRL'S ROOM BEHIND CERAMIC WALLS AND PLASTER CEILING.

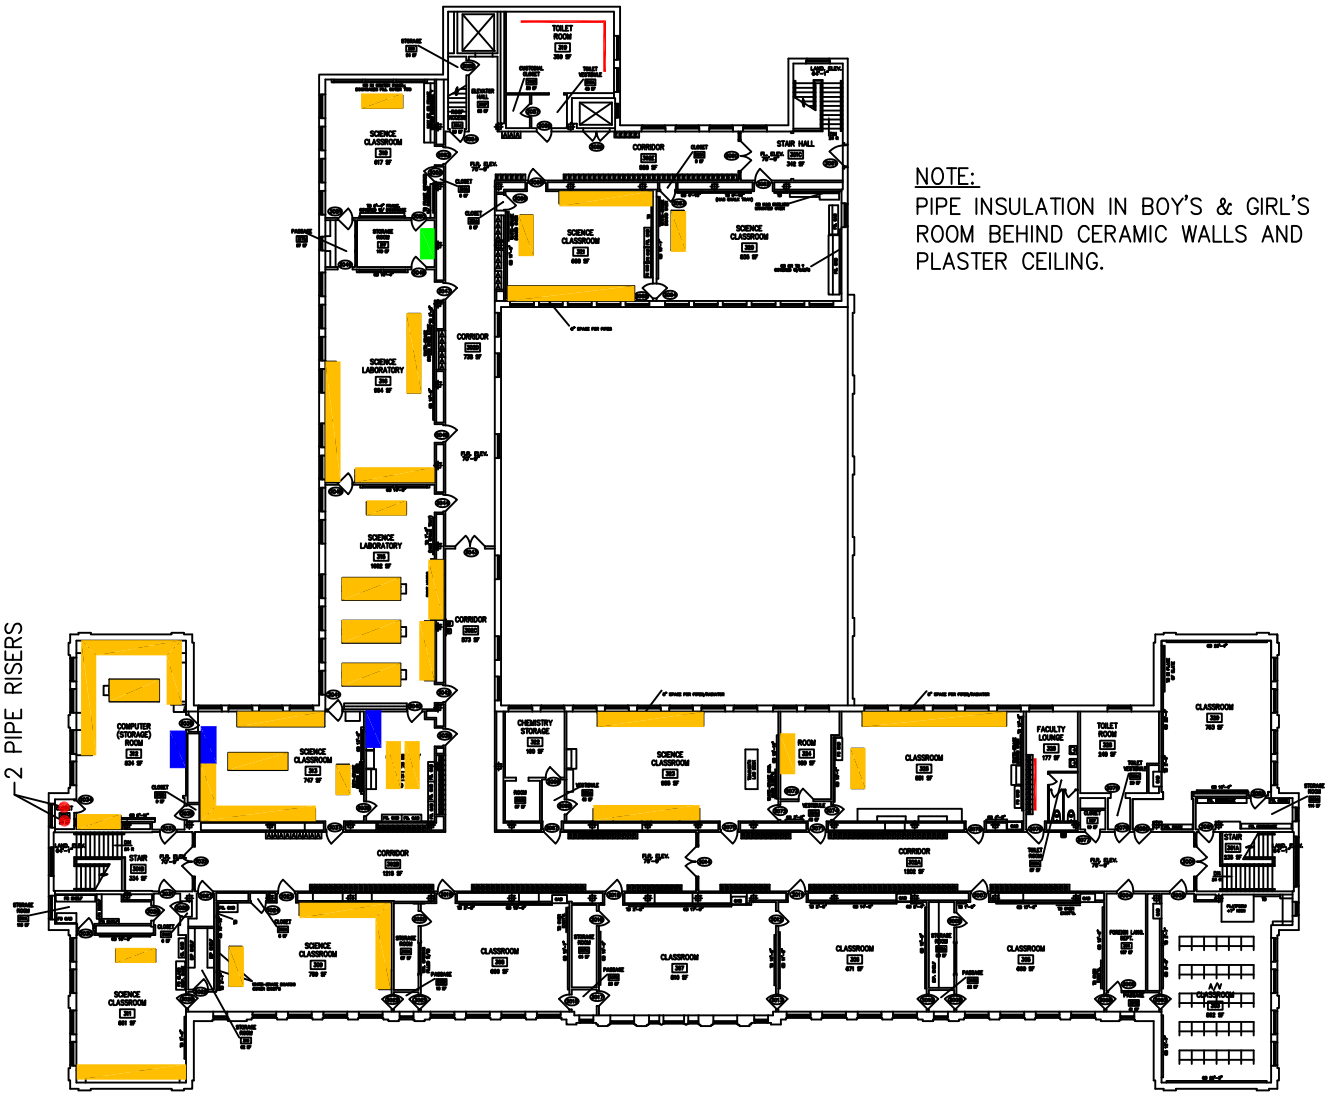
NOTE:
PIPE INSULATION IN BOY'S & GIRL'S ROOM BEHIND CERAMIC WALLS AND PLASTER CEILING.

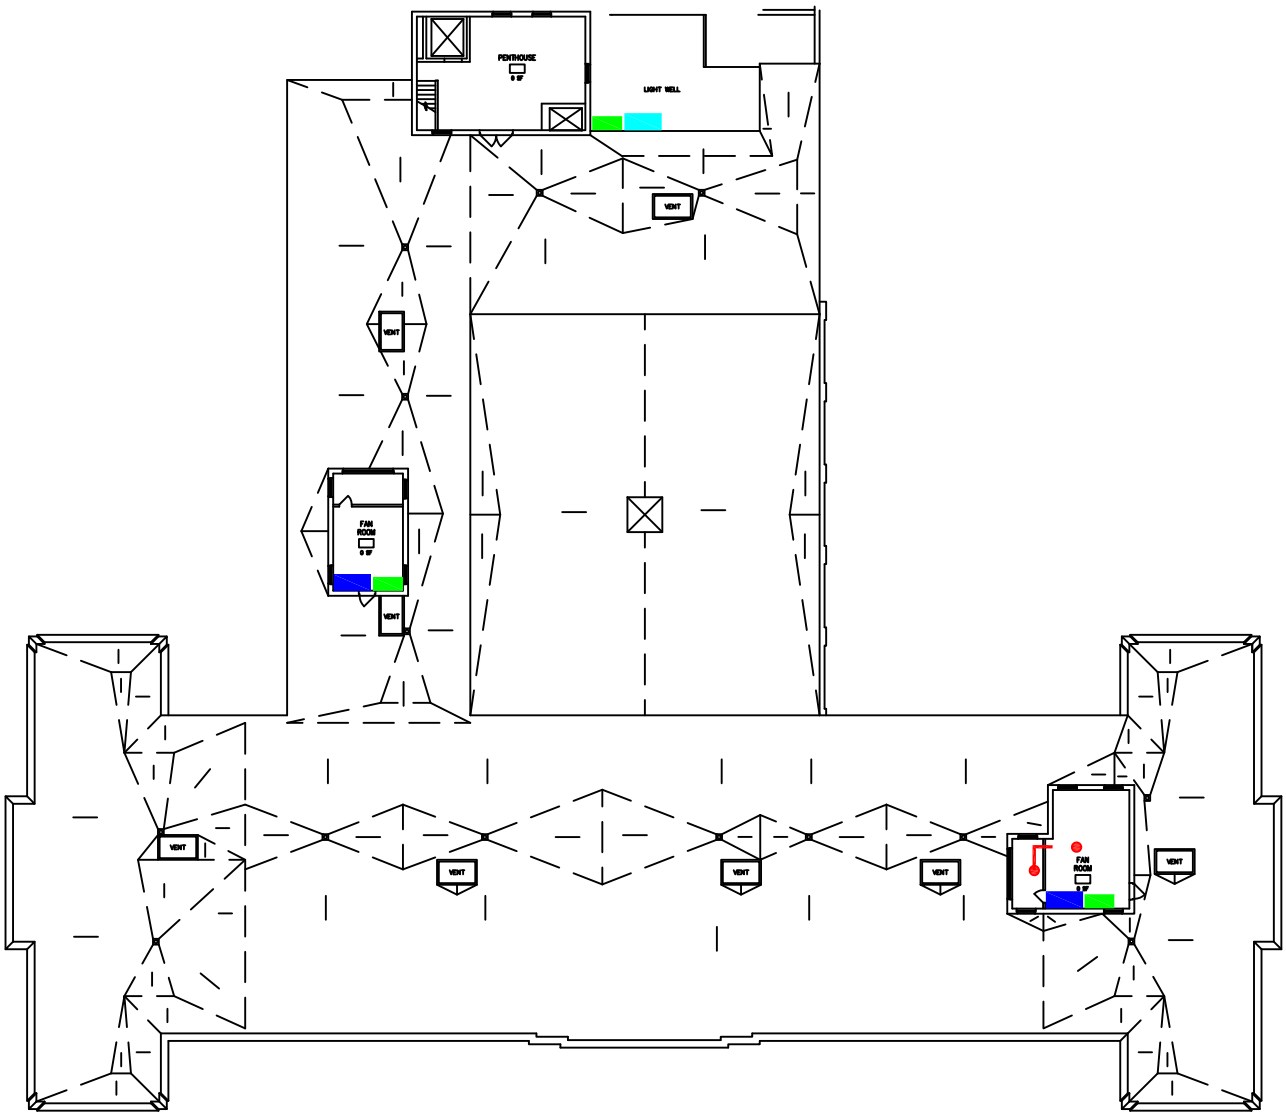
ROOF

NOTE:
PIPE INSULATION IS INSIDE THIRD FLOOR EAVES ACCESSED THROUGH PENTHOUSE.

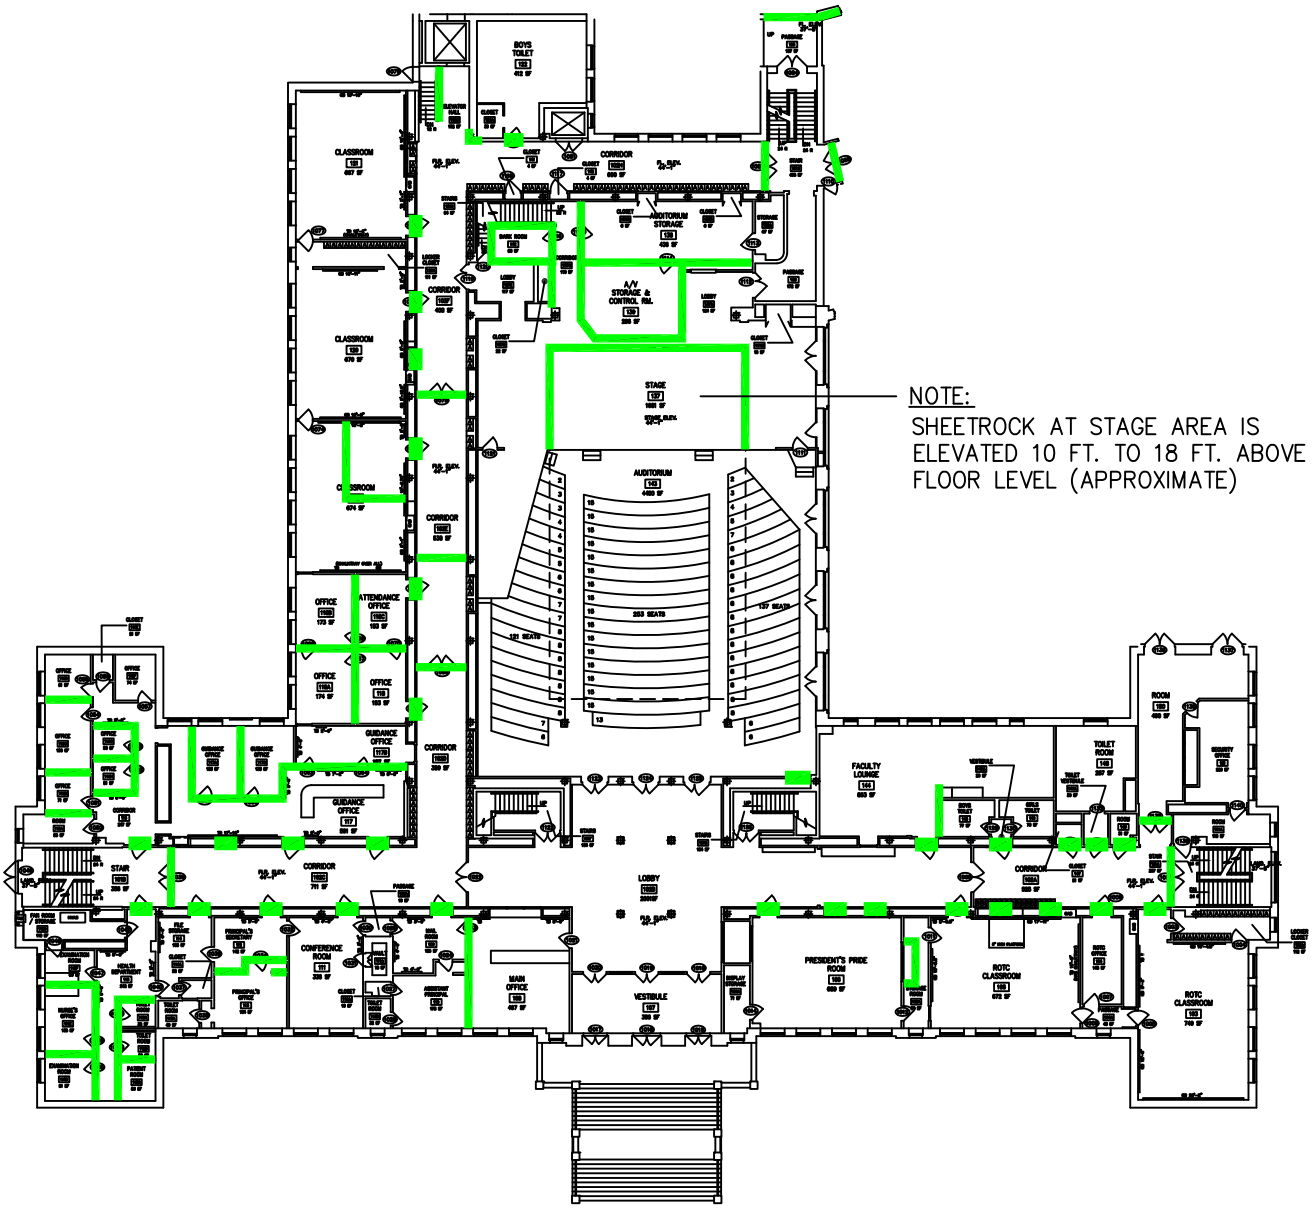
FIRST FLOOR

NOTE:
SHEETROCK AT STAGE AREA IS ELEVATED 10 FT. TO 18 FT. ABOVE FLOOR LEVEL (APPROXIMATE)

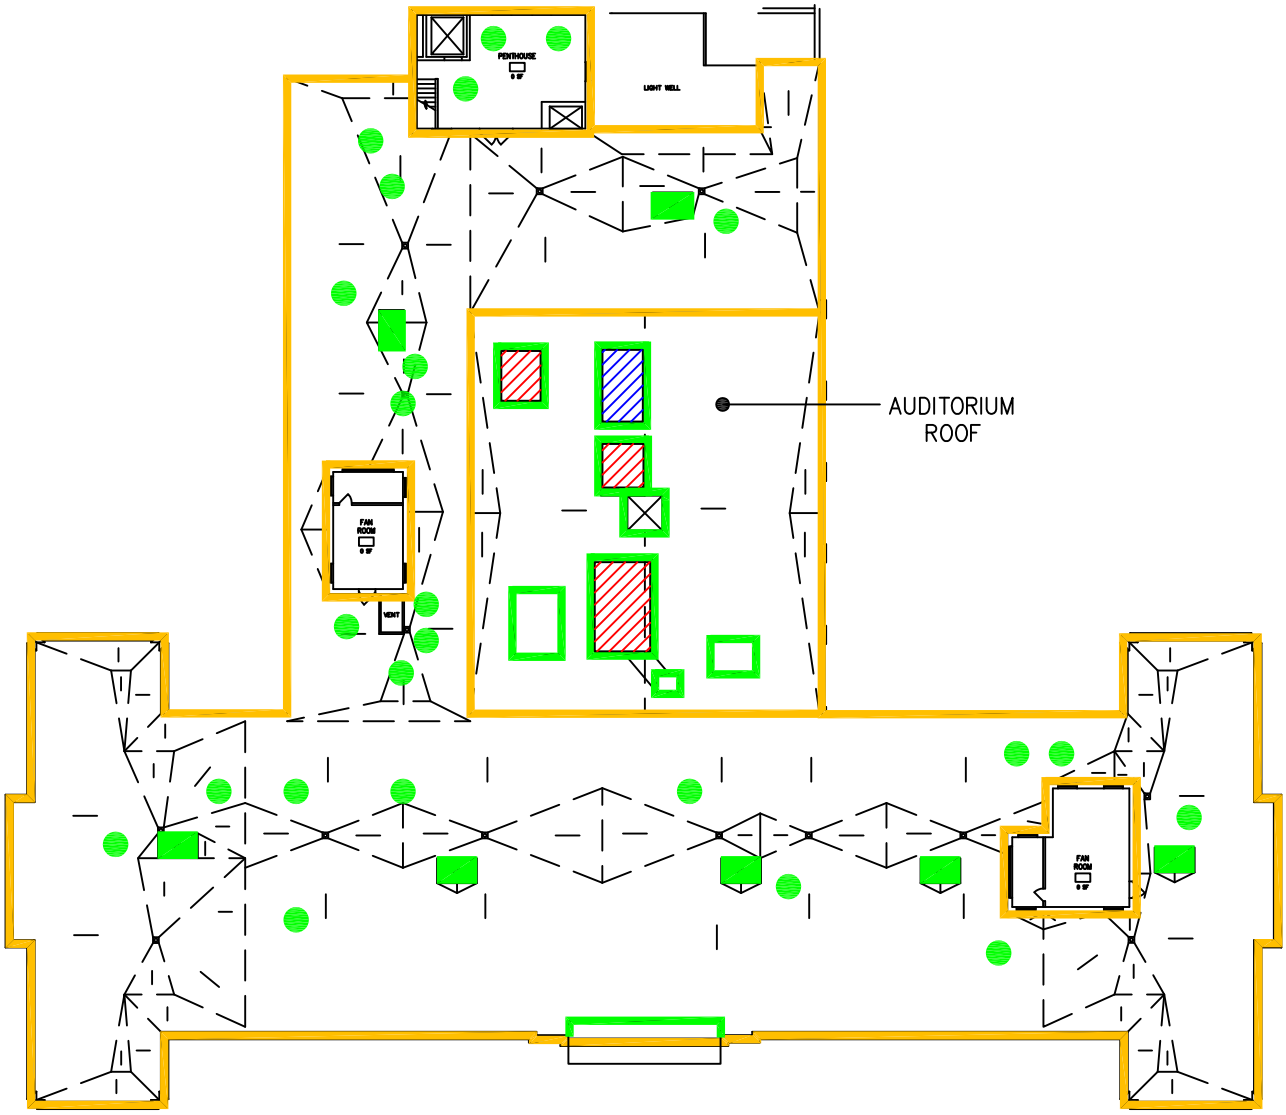
ACM Roofing Materials

ACM FLASHING MEMBRANES AND LIGHT GRAY & BLACK SEALANTS ON COPPER FLASHING ARE ON PENTHOUSE ROOFS, AUDITORIUM ROOF, AND MAIN ROOF.

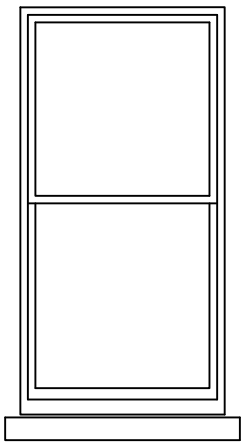
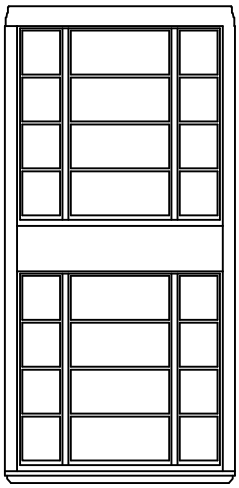
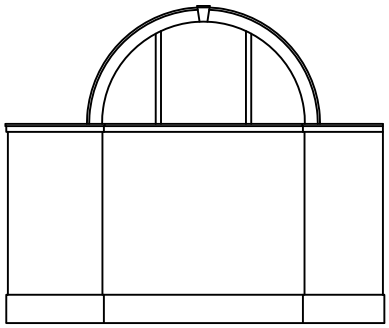
BROWN METAL WINDOWS
AND OLD WOOD WINDOWS
BEHIND BROWN METAL WINDOWS

1. ACM BLACK WINDOW GLAZING ON PLEXIGLASS WINDOWS IN BROWN METAL WINDOWS.
2. ACM WHITE (TOP LAYER) AND GRAY (2nd LAYER) WINDOW CAULKING ON OLDER WOOD WINDOWS BEHIND BROWN METAL WINDOWS.
   [NOTE: THE DRAWING ABOVE REPRESENTS THE FOUR (4) TYPES OF BROWN METAL WINDOWS IN THE BUILDING. THERE IS AN ASSUMED OLD WOOD WINDOW BEHIND EACH ONE.]

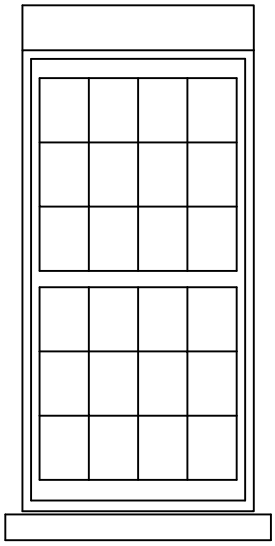
Gray Window Caulking & White Window Glazing on Older Metal Windows[10]	Building Windows @ Rear	25ea (Apprx 9x4.5) 4ea (Approx 5x2.5)
White Seam Filler above Windows @ Brick/Stone[11]	Building Exterior @ Auditorium Roof	40 LF
Black Mastic on Brick Foundation Base[12]	Building Exterior @ Rear	45 LF
Flashing Membrane and Light Gray & Black Sealants on Copper Flashing[13]	Main, Auditorium & Penthouse Roofs	2,400 LF

OLDER METAL WINDOWS AT REAR OF BUILDING

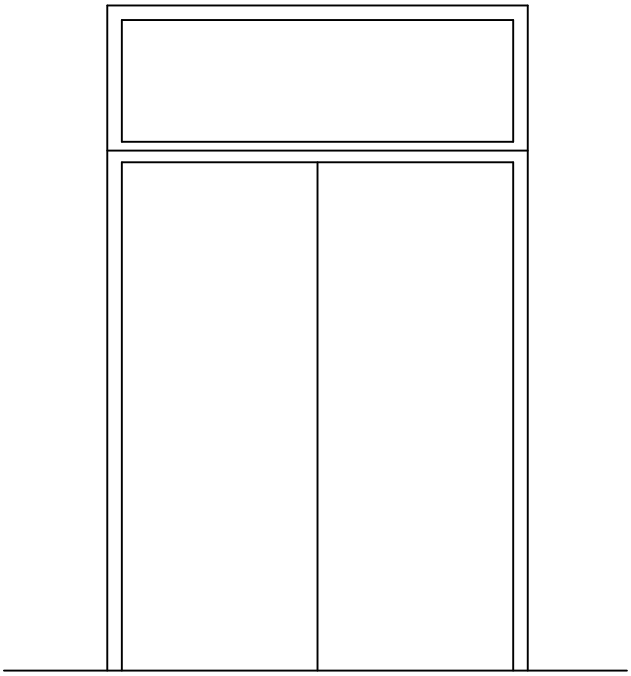
OLD WOOD DOOR FRAMES
(BENEATH BROWN METAL DOOR FRAMES)

ACM WHITE (TOP LAYER) AND GRAY (2nd LAYER) DOOR FRAME CAULKING ON OLD WOOD DOOR FRAMES ASSUMED BENEATH BROWN METAL DOOR FRAMES.

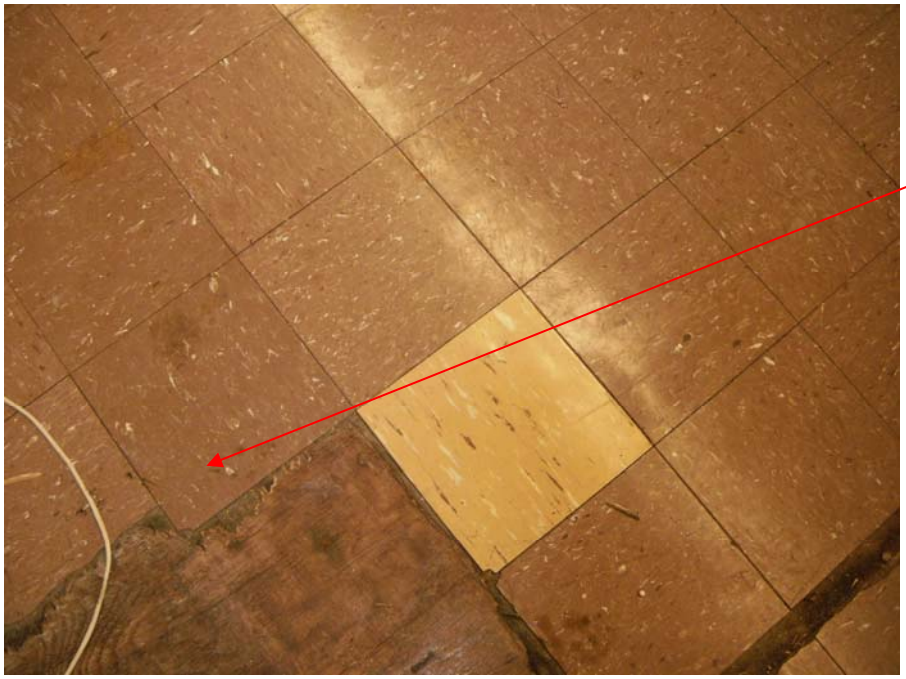
Photo 4

ACM 9"x9" Brown with Brown & White Speck Floor Tile

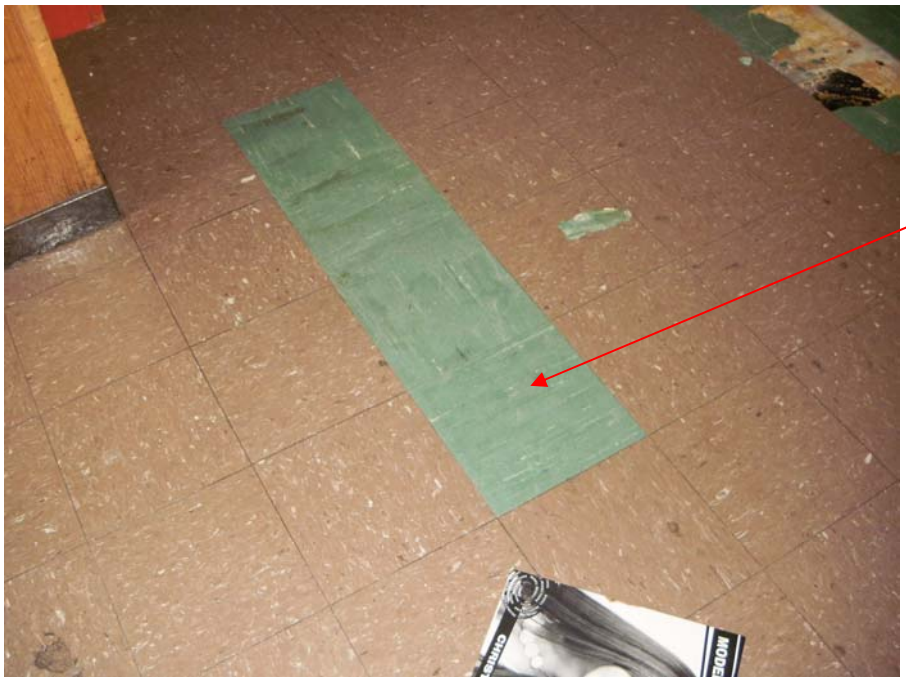
Photo 8

ACM 9"x9" Green with White & Green Streak Floor Tile and Associated Mastic

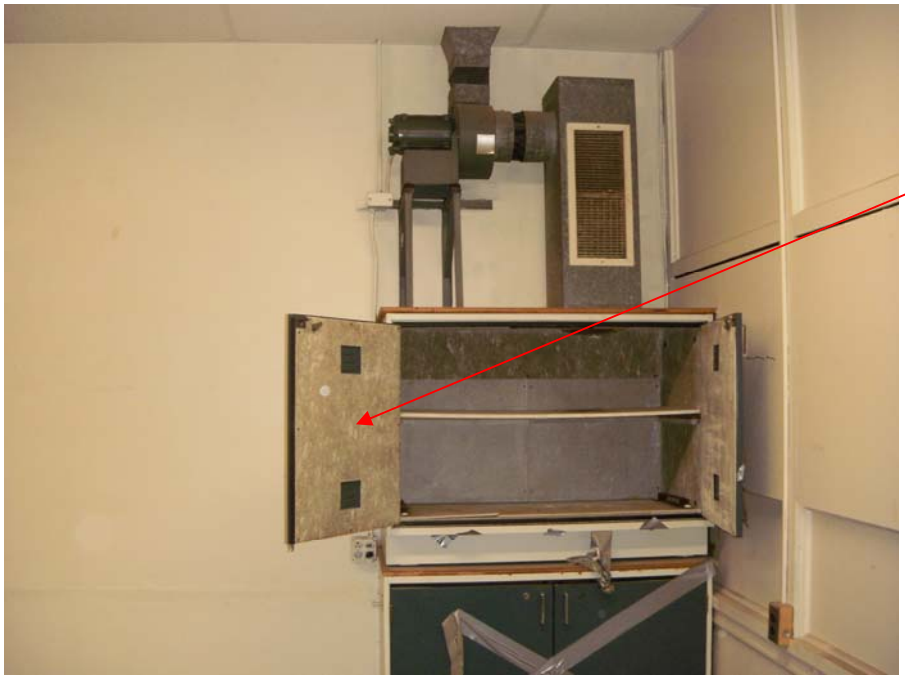
Photo 9

ACM Fume Hood Cement Panels

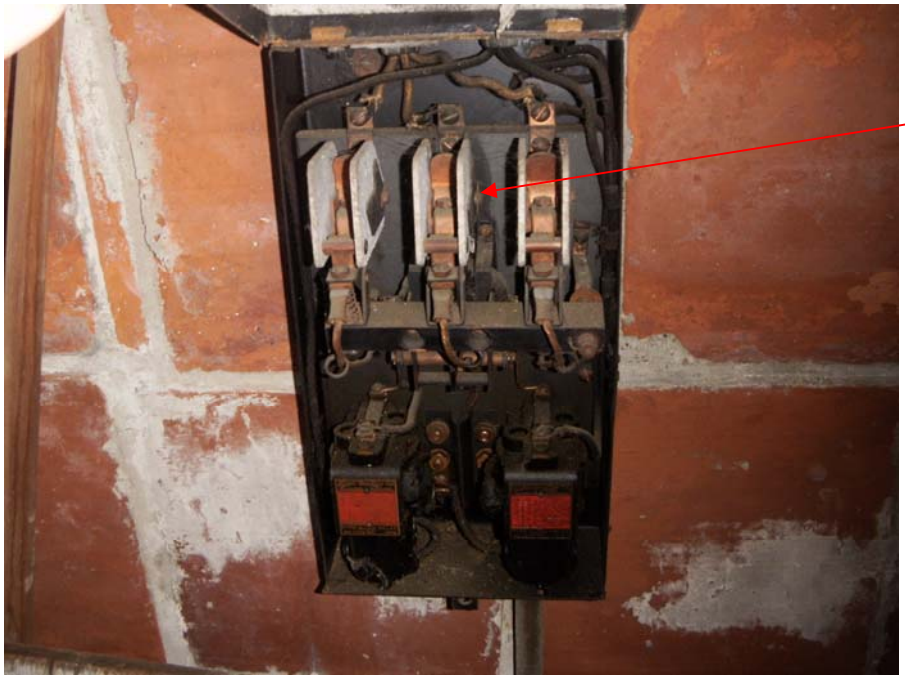
Photo 11

ESIS observed (as noted in the ACM Table above) ACM switch guards and insulating panels in *Allen Bradley Mfg* electrical boxes in the penthouse area and ACM cement board electrical mounting boards throughout the building. ESIS did not sample old electric wires. Older electrical wires were occasionally sheathed in asbestos cloth. Upon termination of electrical service, ESIS recommends sampling of old electrical wiring for ACM.

ACM Switch Guards

Note: ***Allen Bradley Motor Starting Switch***

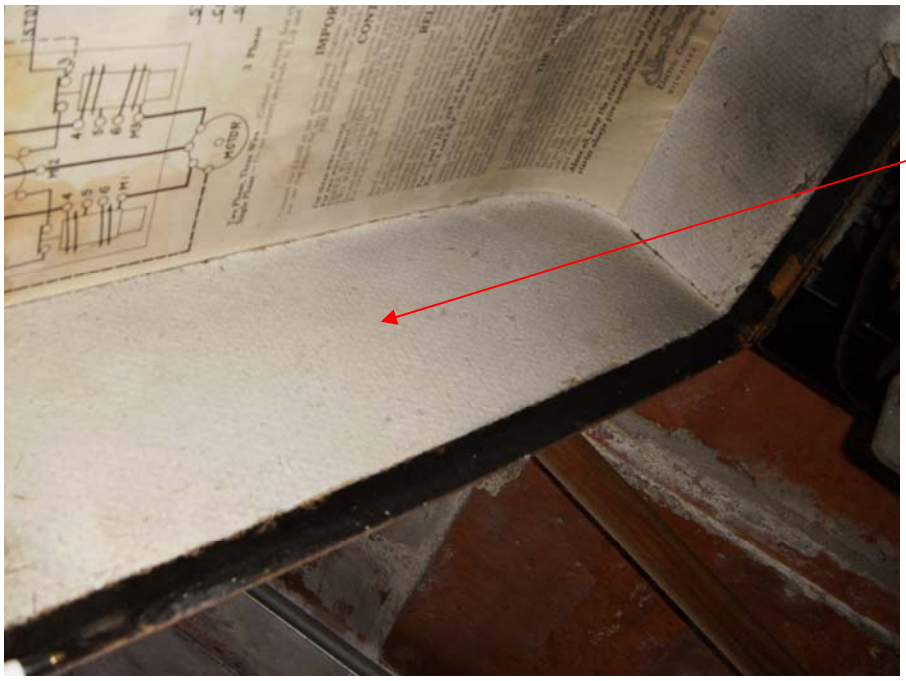
Photo 12

ACM Insulating Box Panels

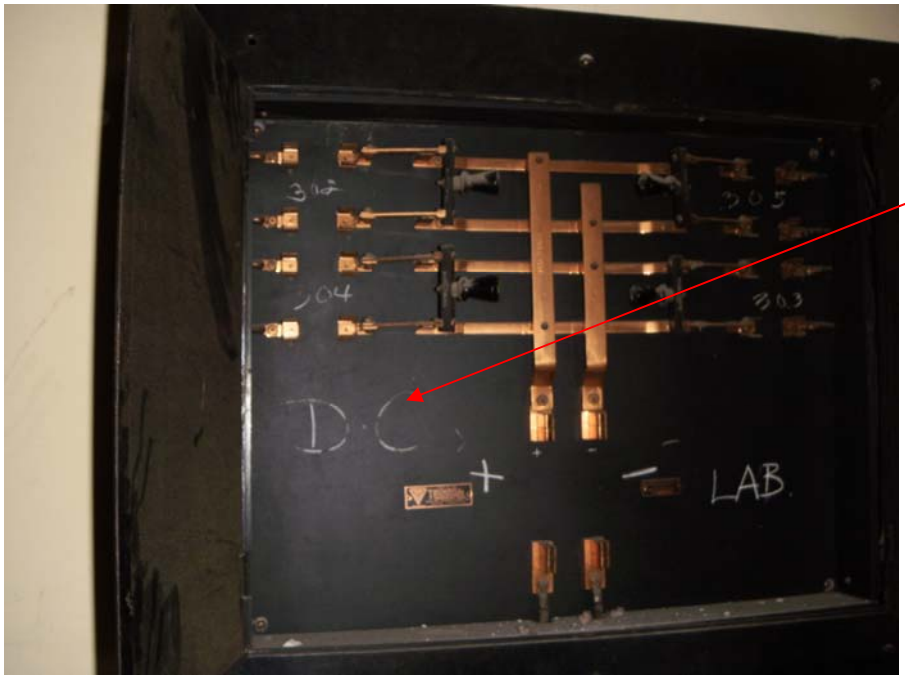
Photo 15

ACM Cement Board Electrical Mounting Panel

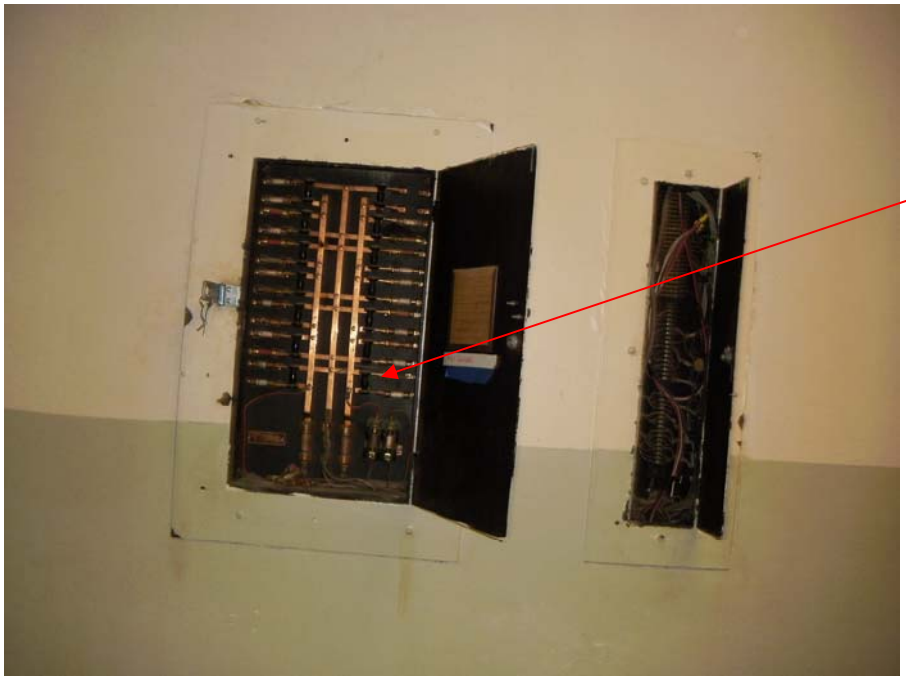
Photo 16

ACM Cement Board Electrical Mounting Panel

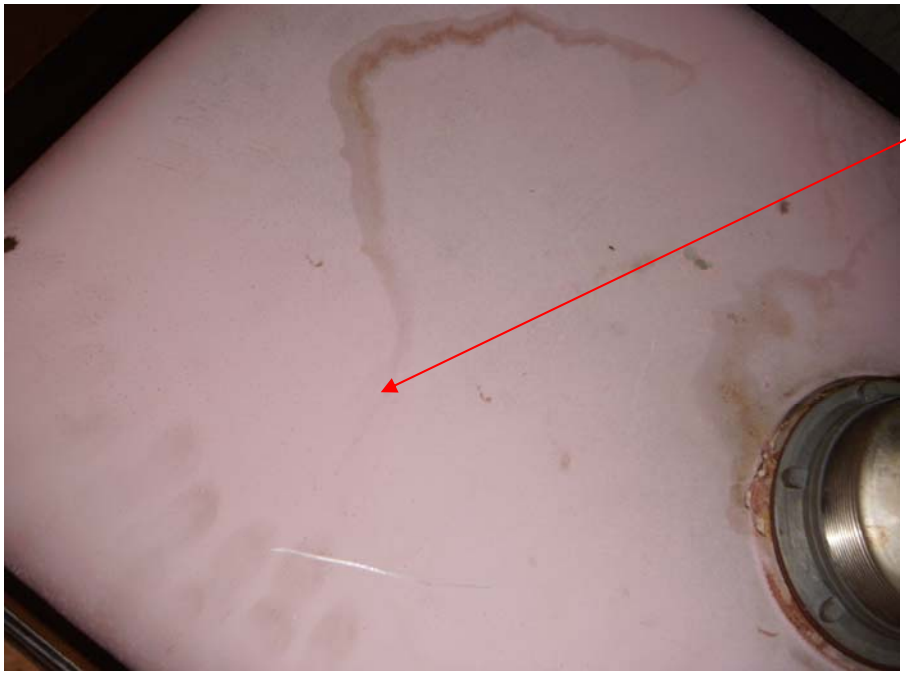
Photo 17

ACM Gray Sink Undercoating

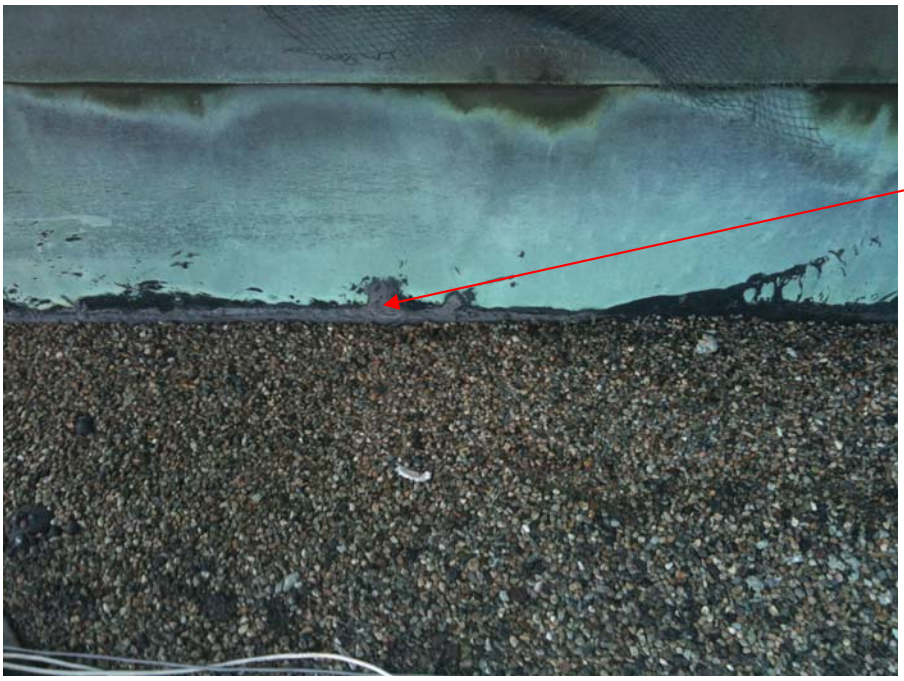
Photo 4

ACM Gray Sealant @ Base of Roof Penetrations

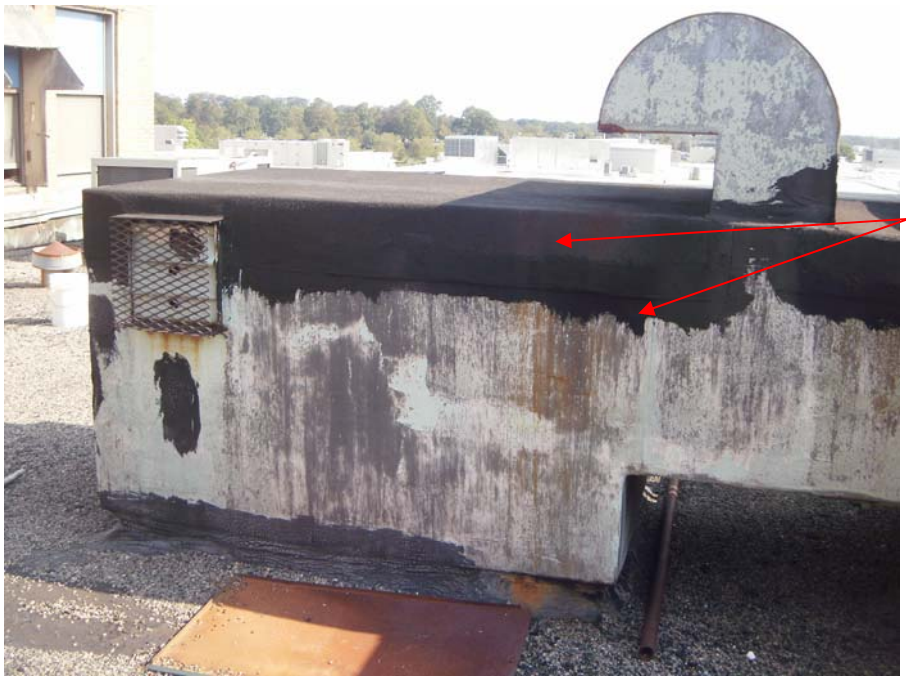
Photo 6

ACM Rolled Asphalt and associated Black Sealant on HVAC Units

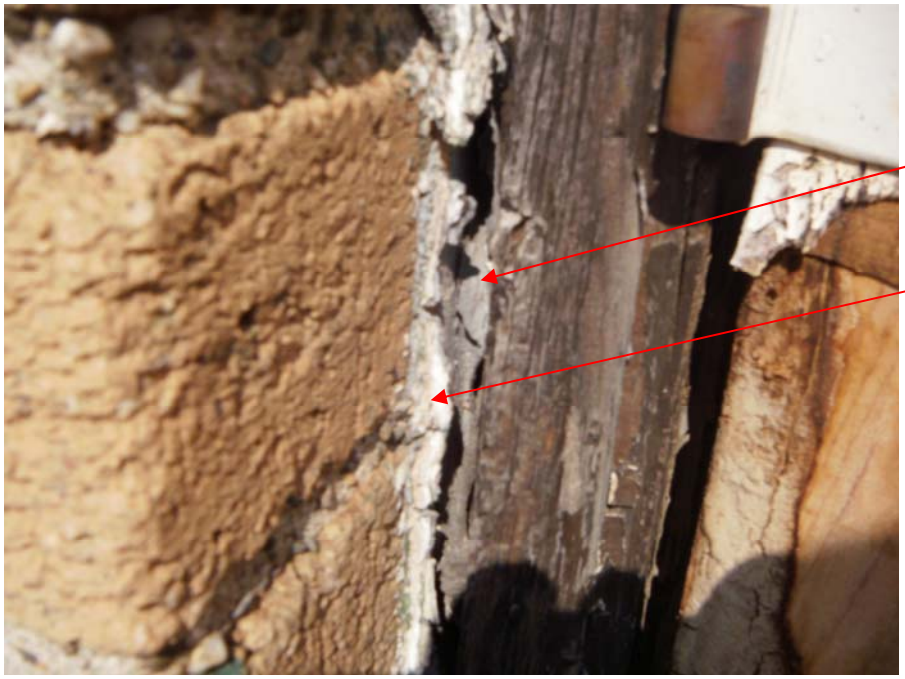
Photo 9

ACM Gray Window Caulking (2nd layer)
